Technical Service Bulletin

RATTLE NOISE FROM INSTRUMENT PANEL CAUSED BY ACTIVE DRIVING DISPLAY

Bulletin No.: 09-010/20

2019-2020 Mazda3 vehicles (Japan built) with VINS lower than JM1BP*****148457 (produced before July 9, 2019)

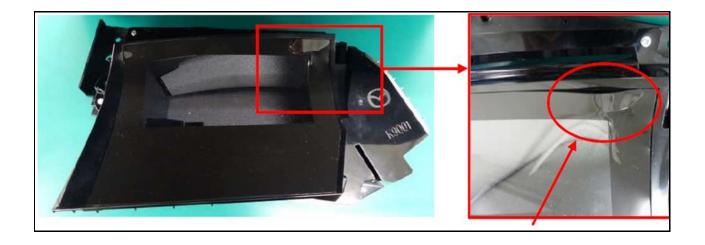
Some customers may notice a rattle noise from the instrument panel while driving that is localized at the active driving display. The noise is generated by a deformed active driving display interfering with the instrument panel. Excessive heat from direct sunlight warps the cover lens, but does not affect the functionality of the active driving display or cause serious damage (such as smoke emission). To correct this concern, the active driving display has been modified.

Customers having this concern should have their vehicle repaired using the following repair procedure.
