SS: 1034639 TBB Minotour Entrance Door seal gap

Applicable Vehicles

2020 Minotours

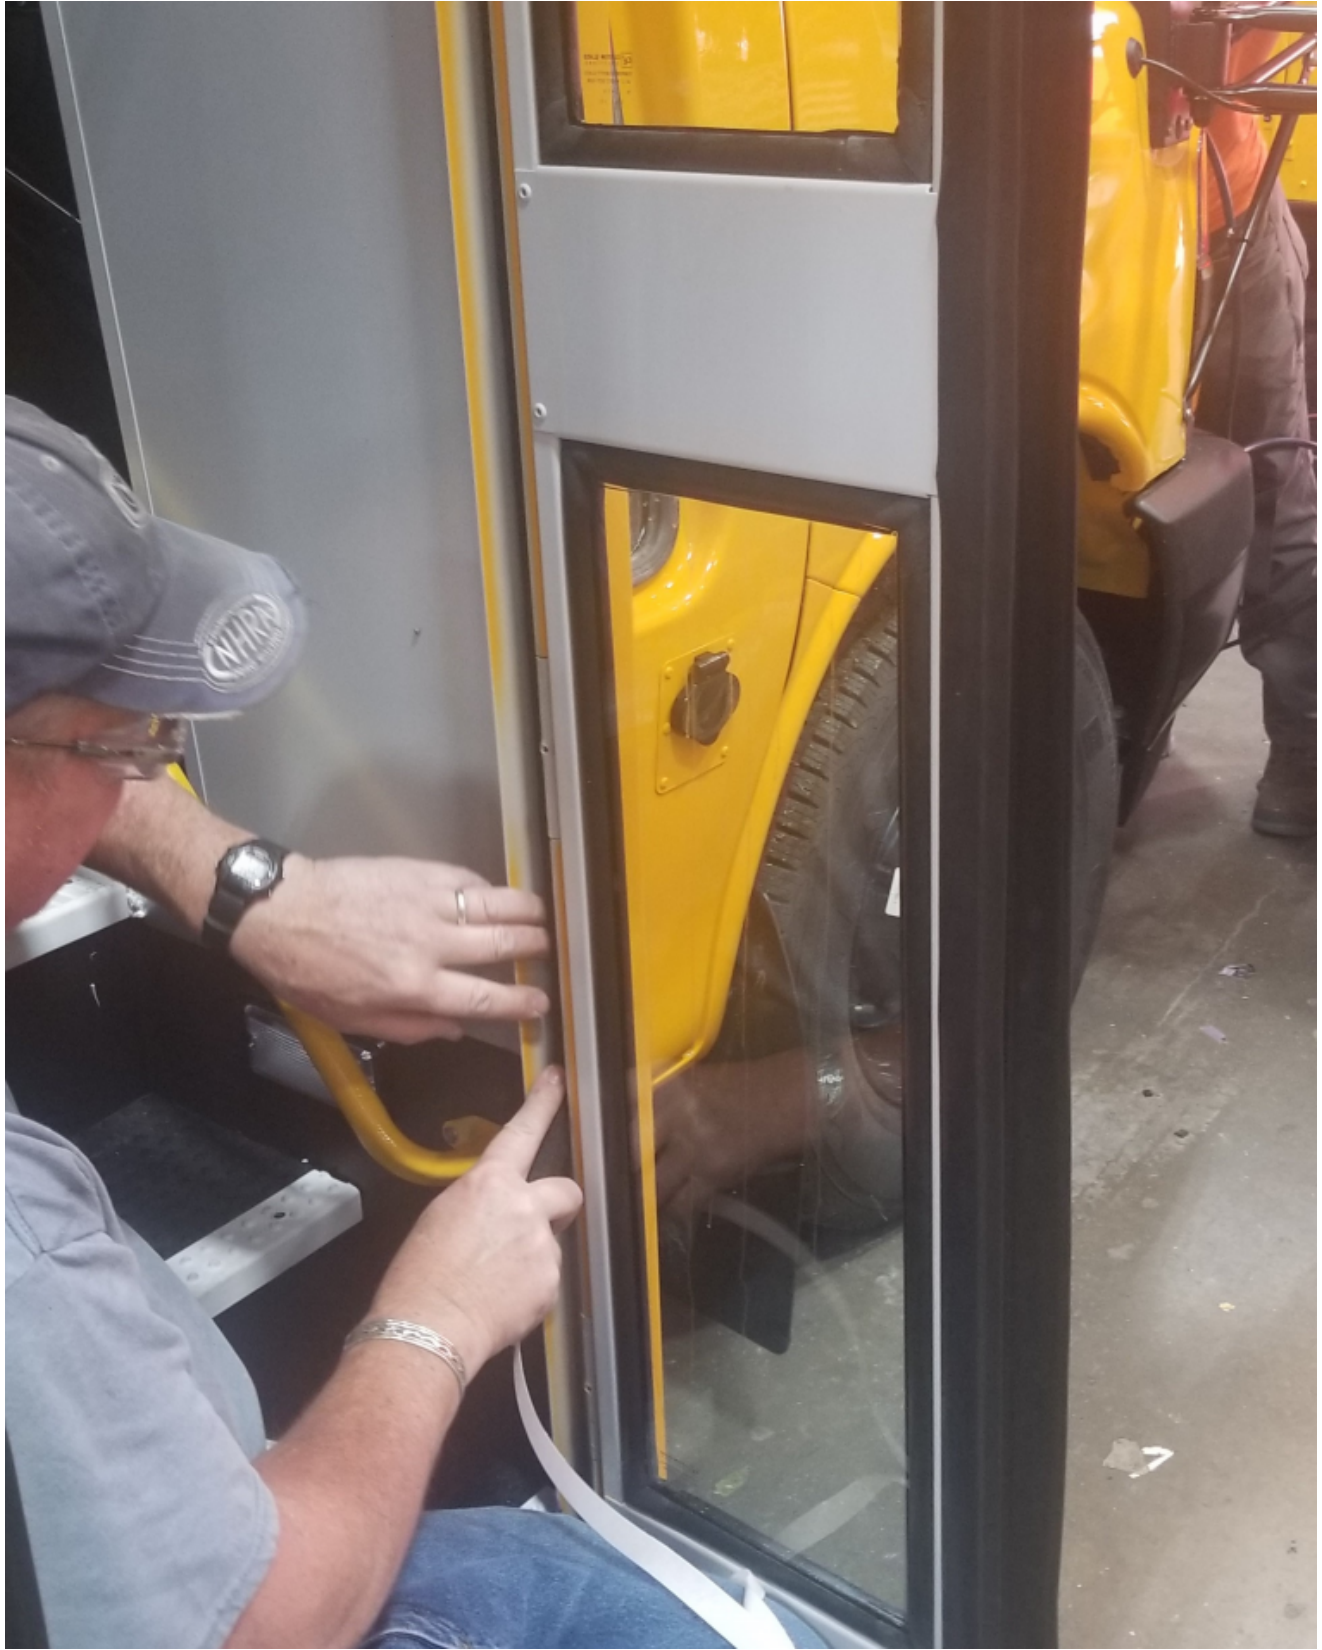
Symptoms

Air Intrusion, cosmetic issue

Adding a Rubber seal TBB 26061370 in the track and then reinstall the original door seal. This will fill the Void. Attach PDF
