# SS: 1034650 TBB Minotour water intrusion

This Service Solution does not imply any special warranty coverage. Standard warranty guidelines and coverage apply. This Service Solution is provided to report a product improvement in preventing water / dust intrusion in the drivers vestibule area.

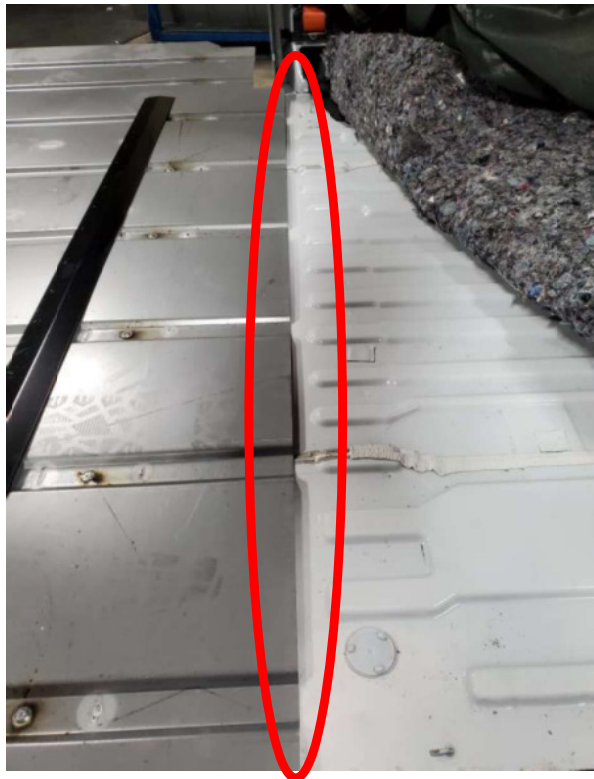
**Before**

Noticing floor board carpet getting wet
