PRODUCT CAMPAIGN BULLETIN

APPLICABILITY: 2003-14 MY Legacy
 2003-14 MY Outback
 2003-06 MY Baja
 2009-13 MY Forester
 2004-11 MY Impreza
 2004-14 MY WRX and STI

SUBJECT: Takata Front Passenger Airbag Module /
 Inflator “Like for Like” Recall

NUMBERS: TKA-20R
 TKB-20R
 TKC-20R

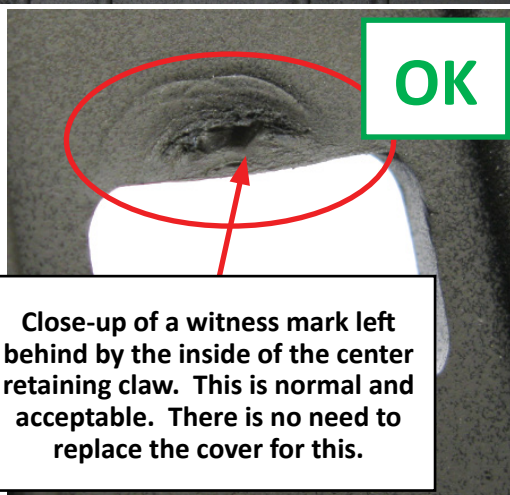
Close-up of a witness mark left
behind by the inside of the center
retaining claw. This is normal and
acceptable. There is no need to
replace the cover for this.

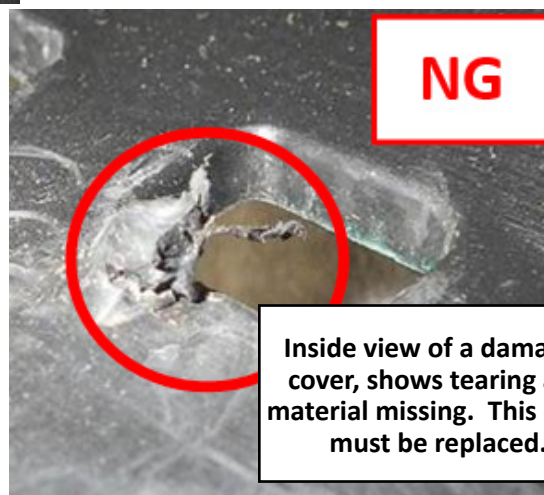
Inside view of a damaged
cover, shows tearing and
material missing. This cover
must be replaced.
