Service Bulletin

Bulletin No.: 16-NA-051

Subject: Active Shutters Inoperative, Malfunction Indicator Lamp (MIL) Illuminated - DTCs P05AE, P059F, P151F, P0071, P0072, P0073, P0074, P3056, U1345, U1501, U1510, U1511, U0285 Set

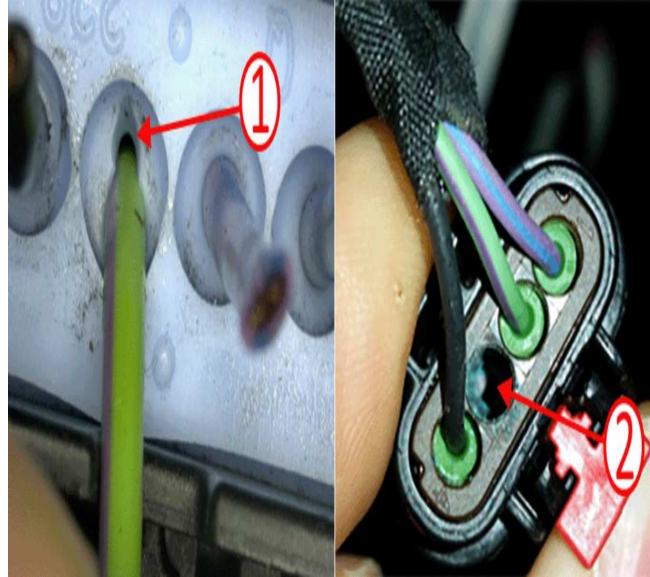
4787001

- Moisture intrusion past damaged (1) and/or missing (2) seals located in the B9, M60B and/or X119 connectors for the ambient air temperature sensor wiring harness.
- Snow and/or ice buildup in the front lower grille area of the vehicle, which could prevent the active aero shutters from opening or closing.
