Service Bulletin

Bulletin No.: 16-NA-122

Subject: Side Detection System Message Being Displayed on Driver Information Center (DIC) - DTC B101E-43 Set

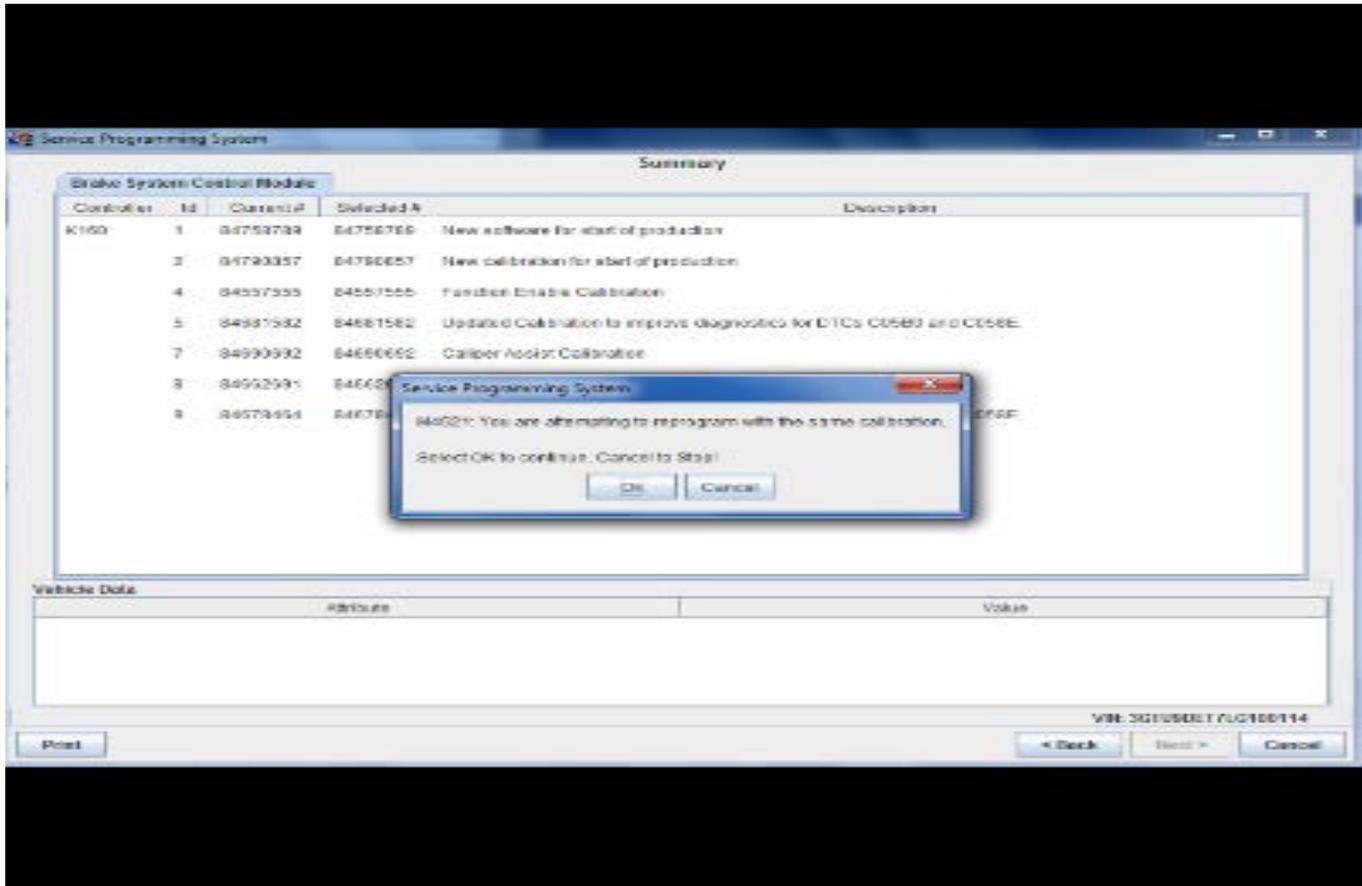
5431207

Important: If the Same Calibration/Software Warning is noted on the SPS screen, select OK and follow screen instructions. After a successful programming event, the WCC is located in the Service Programming System dialogue box of the SPS Summary screen. No further action is required. Refer to the Warranty section of the bulletin.

1. Refer to *Side Object Sensor Reprogramming with SPS* in SI.

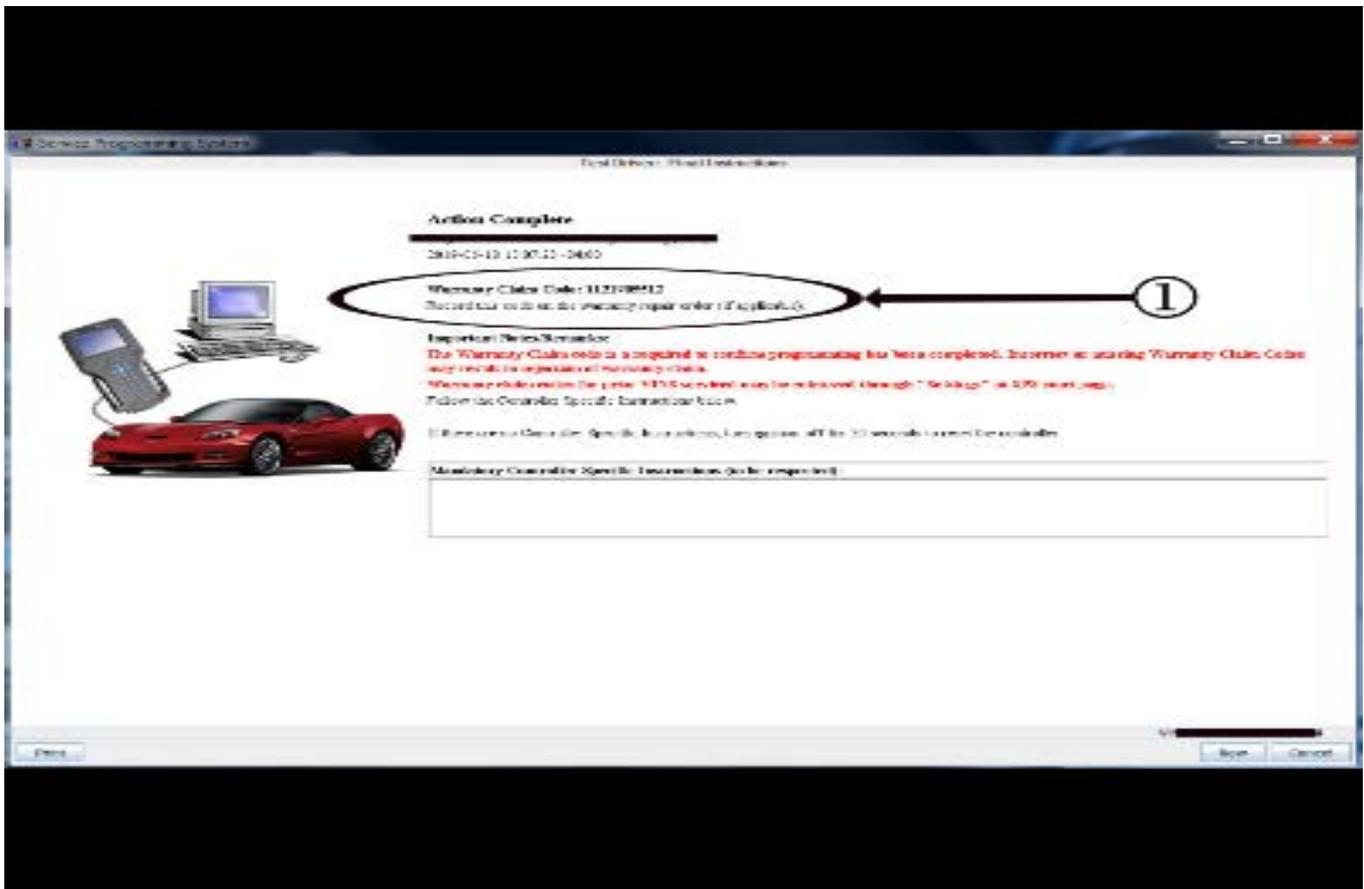
5431209

Important: To avoid warranty transaction rejections, you MUST record the warranty claim code provided on the SPS Warranty Claim Code (WCC) screen on the job card. Refer to callout 1 above for the location of the WCC on the SPS screen.

2. Record SPS Warranty Claim Code on job card for warranty transaction submission.
