Service Bulletin

Bulletin No.: 16-NA-383

Subject: Information on Rough Idle, Crank No Start, Extended Crank or Misfire Due to Excessive Carbon on Top of the Valves or Sticking Valves, Malfunction Indicator Light (MIL) Illuminated - DTC P0300, P0301, P0302, P0303, P0304, P0305, P0306, P0307, P0308 Set

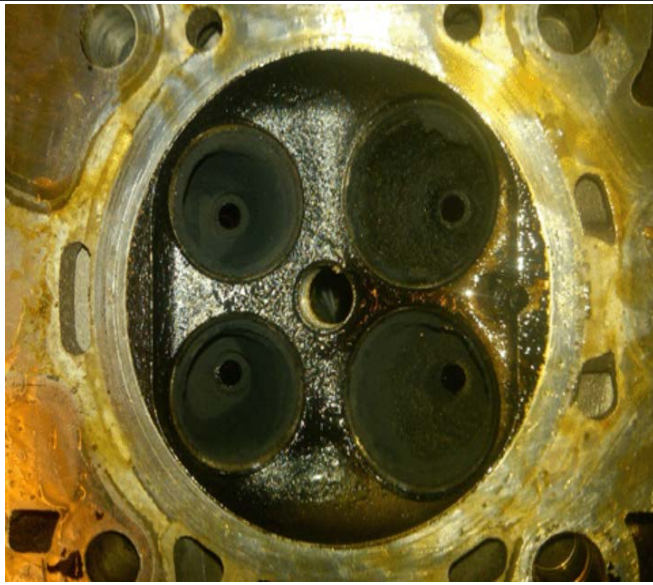
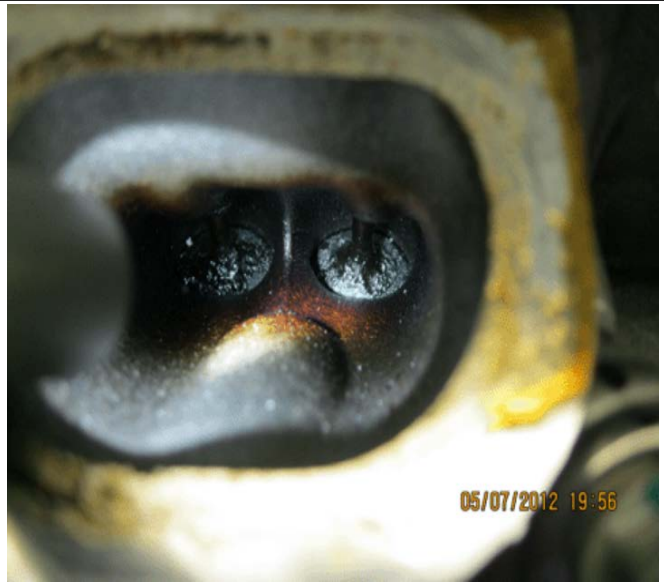
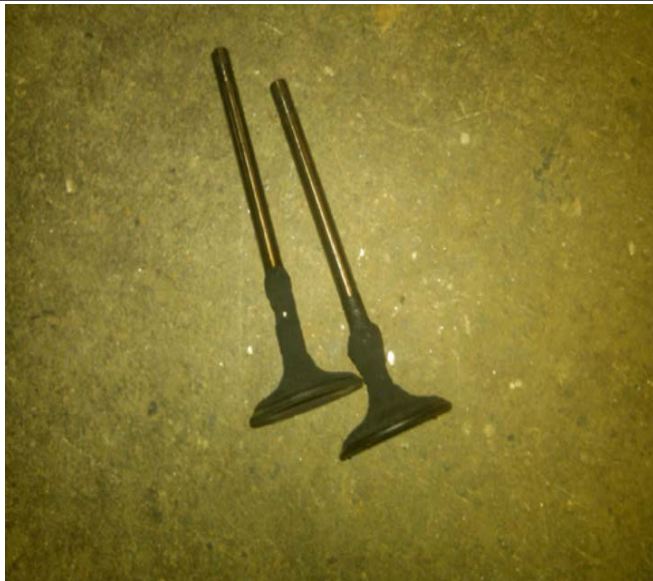
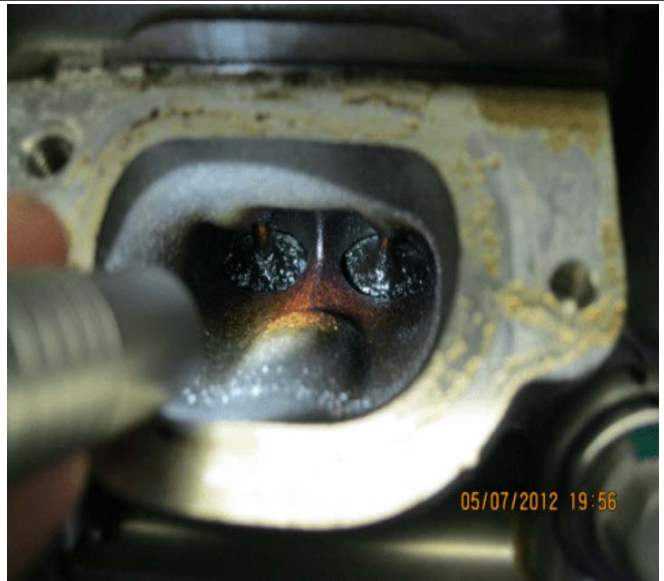
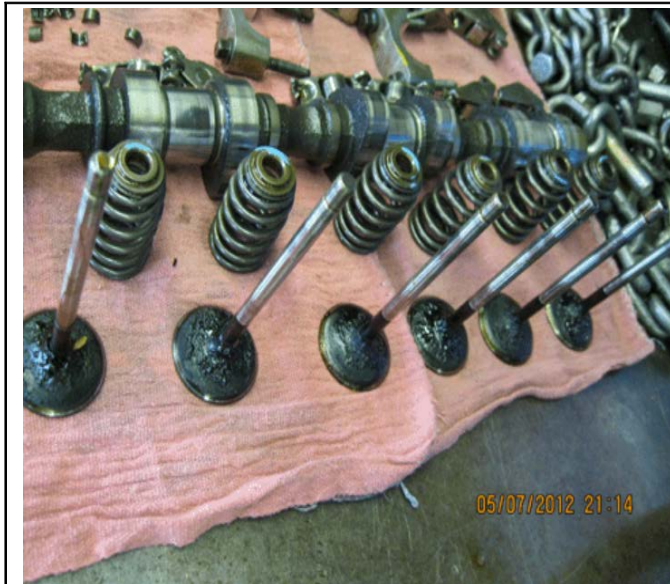
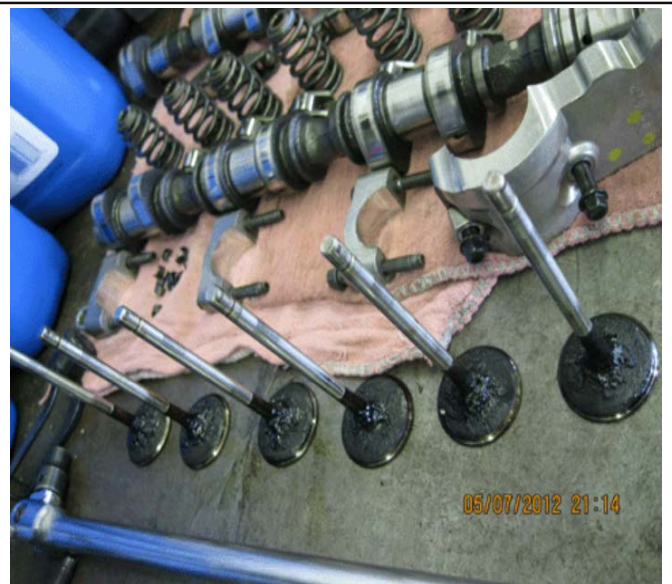
The graphics below may show typical carbon build-up during engine disassembly and inspection of the cylinder heads:

When the engine is cold, the compression on multiple cylinders may be at 0 kPa (0 psi).

The engine also may pop through the intake or exhaust while cranking and the spark plugs may be fuel-fouled when inspected.

Some engines may also experience valve damage or cam followers that are out of position as a result of this.

If this concern is encountered, perform SI diagnosis. If the SI diagnosis leads to a compression loss due to a valve sealing concern and/or eliminates everything else external to the engine, the following information may help:

- If there is no sign of valve damage or cam followers that are out of place, perform the following procedure to free up sticking valves and to remove carbon from the valves and pistons.
- If valve damage is present or if there are cam followers that are out of place, perform engine mechanical repairs as necessary to correct the concern and then perform the procedure below to prevent the concern from returning.

- Perform an upper engine and valve cleaning procedure.
- Below are examples of valves that have gone through a Top Engine cleaning procedure.

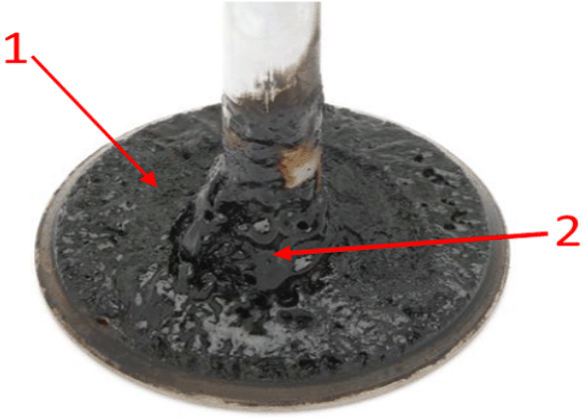
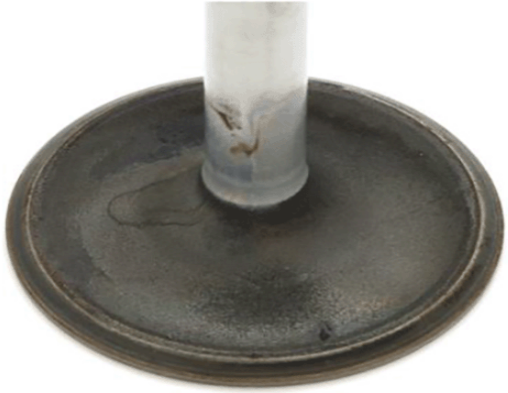
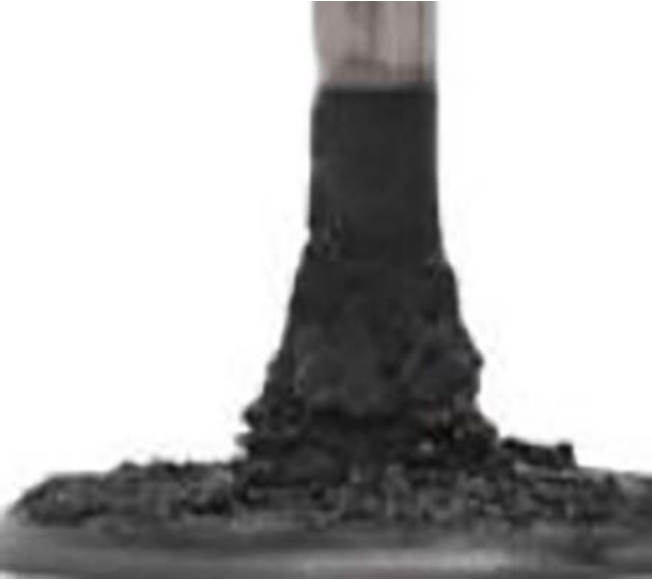
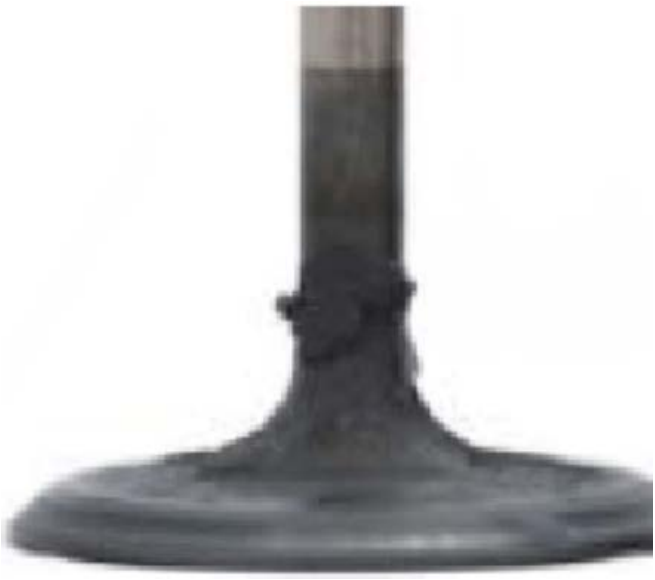
Before Cleanup	After Cleanup
