# Service Bulletin

Bulletin No.: 16-NA-405

**Subject:** Poor Engine Performance in Extremely Cold Weather Conditions, PCV Bypass Hose and Charge Air Cooler Icing for LUV Engines, Malfunction Indicator Lamp (MIL) Illuminated - DTC P0299, P0236, P2227, P00C7 Set

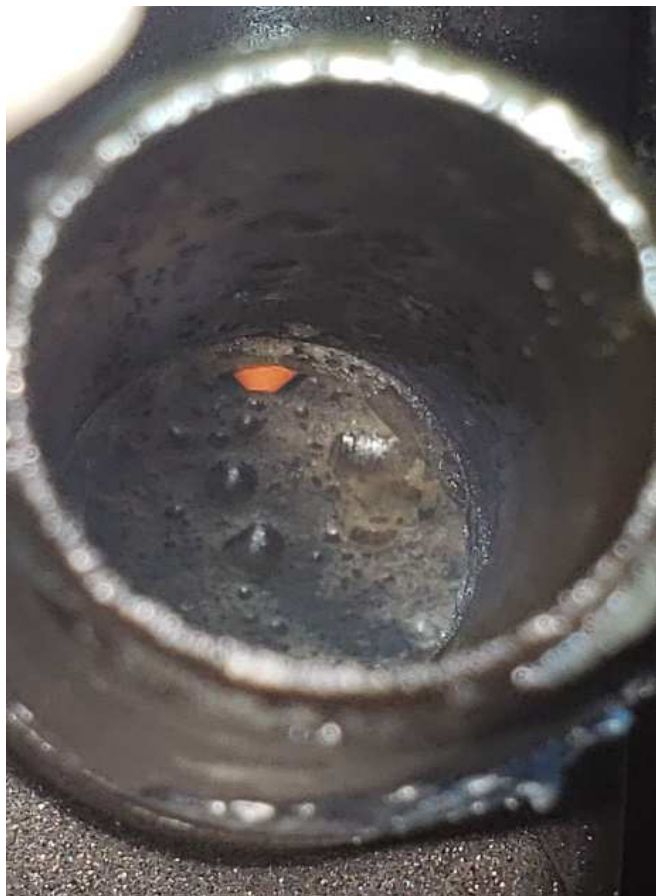
5286434

2. Inspect the vacuum ports of the intake manifold for ice accumulation.

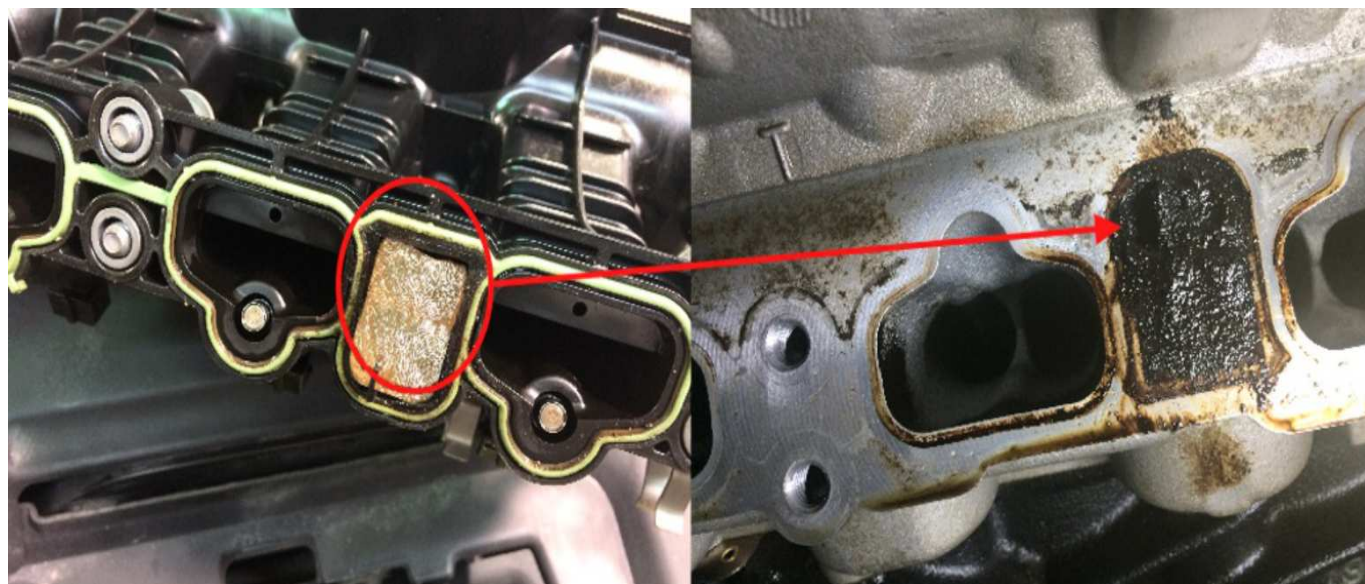
5286457

3. Inspect the PCV intake runner for ice build-up blocking the cylinder head as shown above.

4. Clean any ice/sludge/water/carbon out of the PCV pipes/hoses, the PCV nipple on the intake manifold, the PCV intake runners and the orifice between the #2 and #3 intake ports.
5. Install the intake manifold.

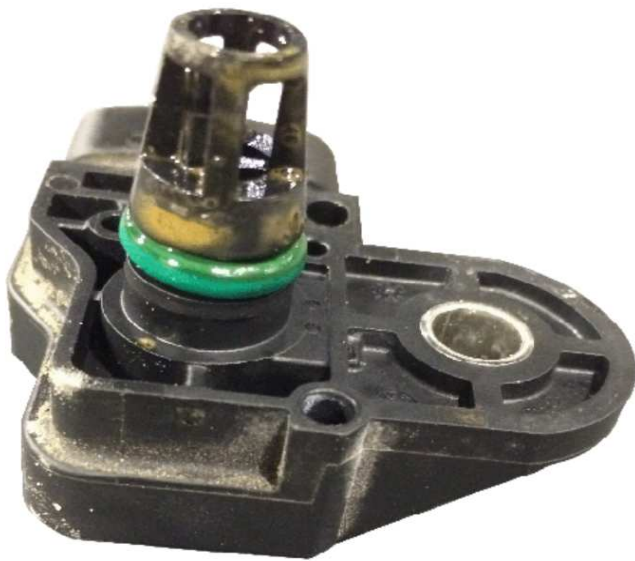
4910683

2. Inspect the IAPT sensor for any contaminates.

**Important:** Due to the sensitivity of the IAPT, **Do Not** use any chemical cleaners including water and **Do Not** use compressed air to remove contaminates.

3. Allow time for any ice build-up to melt by placing the sensor port down.
4. Clean the sensor with a clean towel.
5. Inspect the IAPT sensor for any contaminates.
6. Install the sensor into the elbow duct.
