Service Bulletin

Bulletin No.: 17-NA-140

Subject: Rattle Noise from Rear of Vehicle and/or Wind or Buffeting Noise While Driving with One Window Lowered

Brand:	Model:	Model Year:		VIN:		Engine:	Transmission:
		from	to	from	to		
Chevrolet	Camaro	2016	2020			All	All

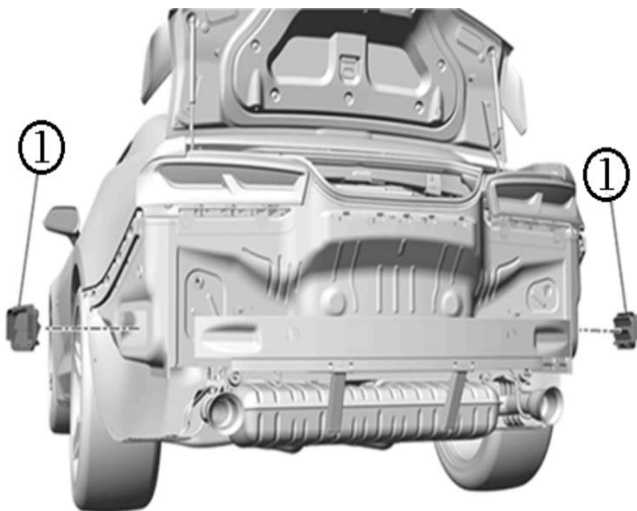
4773146

Involved Region or Country	North America, Europe, Russia, Middle East, Argentina, Brazil, Bolivia, Chile, Colombia, Paraguay, Uruguay, Japan, GM Korea Company, China
Condition	Some customers may comment on a wind or buffeting noise that is heard in the vehicle cabin while driving with one window lowered and/or a rattle type noise from the rear while driving.
Cause	The cause of the condition may be the two flap design of the original pressure relief valves in the rear of the vehicle.
Correction	Verify the condition and replace both original body pressure relief valves with a four flap design valve, following the Service Procedure below.

Note: The noise can generally be duplicated by driving at speeds greater than 48 km/h (30 mph), with one window lowered. If another window in the vehicle is lowered, even slightly, the buffeting noise will stop instantly.

For vehicles exhibiting this condition, replace both of the original body pressure relief valves (1) with two of the four-flap design valves listed in the Parts Information table. Refer to *Body Pressure Relief Valve Replacement* in SI.
