Service Bulletin

Bulletin No.: 17-NA-235

Subject: Clicking Noise from Front Axle During Takeoff/Acceleration

Brand:	Model:	Model Year:		VIN:		Engine:	Transmission:
		from	to	from	to		
Chevrolet	City Express	2015	2018			All	All

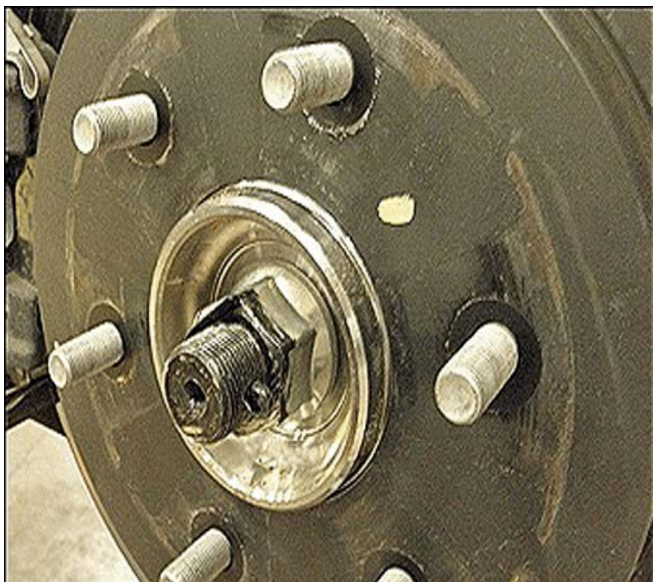
4830999

Involved Region or Country	North America
Condition	Some customers may comment on a clicking type noise originating from the front axle area during takeoff/acceleration.
Cause	This may be due to lack of grease on the hub bearing surface.
Correction	Remove axle nut, push axle back but not fully remove, and apply grease to the front wheel hub bearing surface.

1. Gain access to the wheel bearing cotter pin by referring to the *Front Wheel Drive Shaft Replacement* procedure in SI.

2. Remove the front wheel bearing cotter pin and lock nut from the axle.

Note: Do not remove the axle from the hub or transmission.
