Service Bulletin

Bulletin No.: 18-NA-026

Subject: Transmission Fluid Leak from Transmission Oil Cooler Line Fitting Retaining Bolt

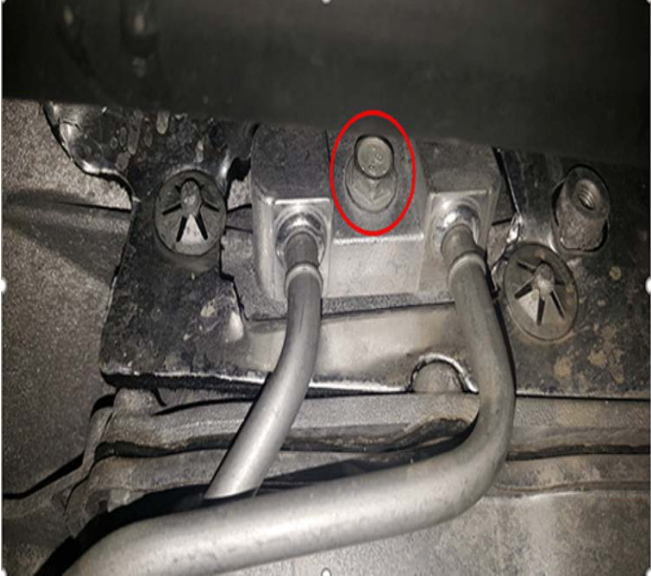
<p style="text-align: right;">4951557</p> <p>This condition may be caused by transmission fluid leaking from the transmission oil cooler line retaining bolt passage, located on the left side of the transmission case. The case area near the threaded passage may contain porosity, which can contribute to the leak.</p>
<p>Correction</p>
