# Service Bulletin

Bulletin No.: 18-NA-383

**Subject: Water Found in Rear Interior of Cab, Water Leak at Rear Sliding Window**

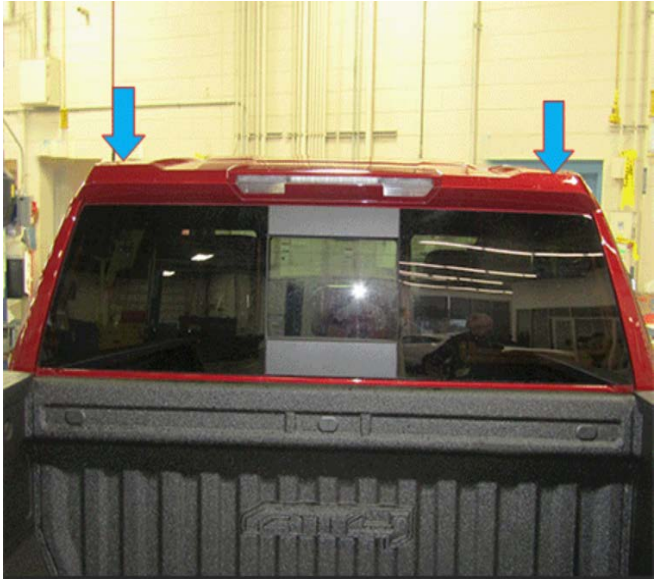
5203798

The cause of the condition may be cracking in the rear sliding window plastic upper rail glass guide. The plastic upper rail glass guide may develop small fractures/cracking which allows water to pass through on the glass side of the urethane that attaches to the vehicle body.

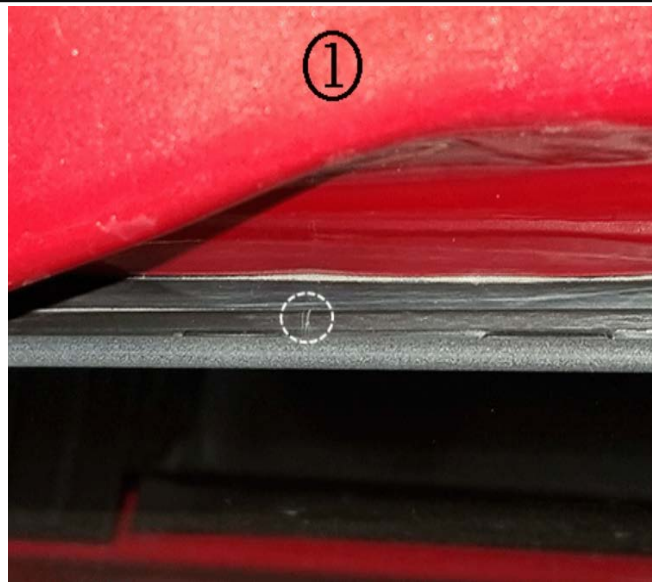
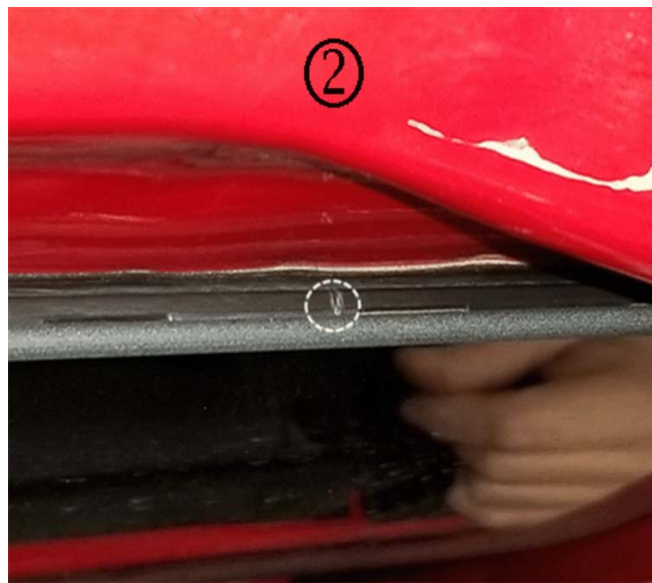
**Note:** The cracks can be in the left and/or right side of the rear sliding window plastic upper rail glass guide which is covered by the roof rear spoiler. Examples of a left (1), then right side (2) visual crack (with the spoiler removed) are shown in the graphics above.

R & R the roof rear spoiler and apply seam sealer to the rear sliding window top encapsulate, following the steps in the Service Procedure below.
