# Service Bulletin

Bulletin No.: 19-NA-098

**Subject: Knock in Front End Over Bumps or Turning Corners at Slow Speed**

Brand:	Model:	Model Year:		VIN:		Engine:	Transmission:
		from	to	from	to		
Chevrolet	Equinox	2018	2020				
Holden	Equinox						
GMC	Terrain

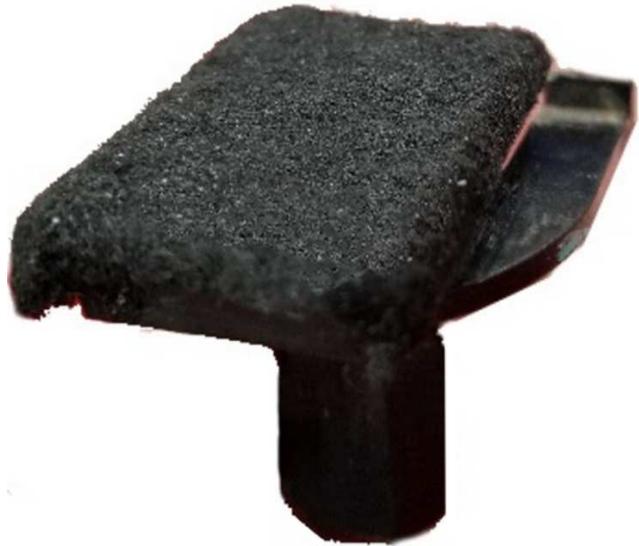
<p style="text-align: right; font-size: small;">5326741</p> <p>If the noise has been validated to be coming from the radiator mounts, installation of BSR tape can be applied to the sleeve.</p>

<b>Involved Region or Country</b>	North America, Middle East, Israel, Argentina, Brazil, Chile, Columbia, Ecuador, Paraguay, Uruguay, South Korea, China, Thailand, Australia, New Zealand, Egypt and Africa.
<b>Condition</b>	Some customers may comment that a knocking noise can be heard from the front end of their car while driving over speed bumps or turning corners at low speed.
<b>Cause</b>	This condition may be caused by a clearance issue between the radiator housing and the radiator support sleeve. ⇒ Low speed movement may causes a twist load into the chassis.
<b>Correction</b>
