Service Bulletin

Bulletin No.: 19-NA-160

Subject: Intermittent or Continuous Horn Blowing, Horn Activation Sensitive to the Touch

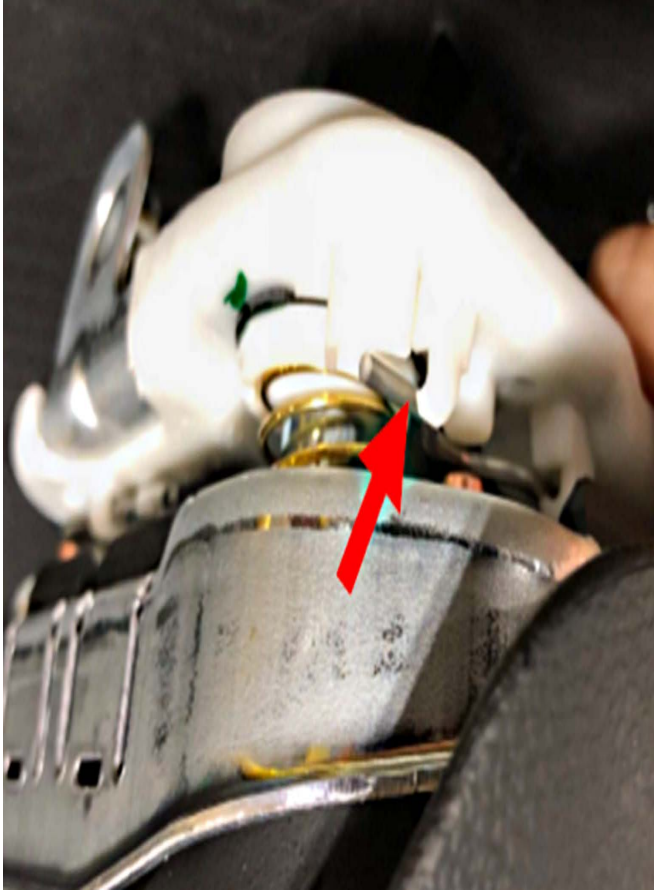
<p style="text-align: right;">5368149</p> <p>The cause of the condition may be that the horn spring, located on the backside of the steering wheel airbag, is out of position.</p>
<p>Correction</p>	<p>Upon verifying the condition, remove the steering wheel airbag assembly and inspect for proper engagement of the horn spring to the airbag housing.</p>
