# Service Bulletin

Bulletin No.: 19-NA-206

**Subject:** Intermittent Shift to Park Message Displayed While Vehicle in Park

**This bulletin replaces 18-NA-297. Please discard 18-NA-297.**

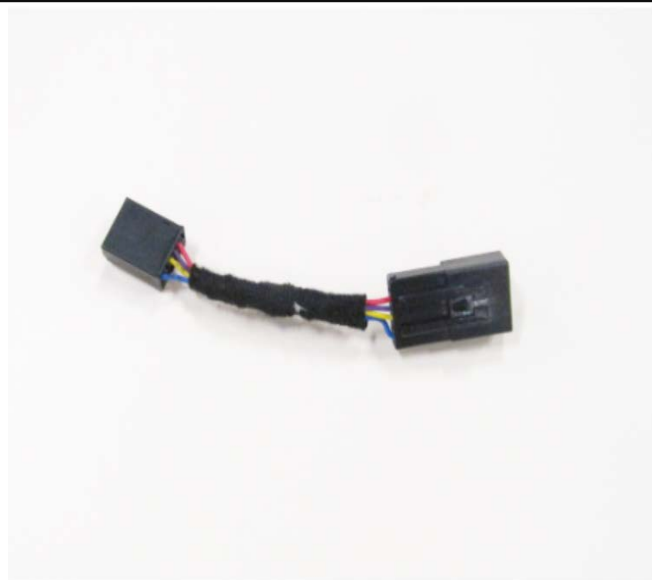
5386336

<b>Involved Region or Country</b>	North America, Europe, Russia, Middle East, Israel, South America, Japan, South Korea, China, Thailand, Australia, New Zealand, Africa
<b>Condition</b>	Some customers may comment on seeing an intermittent Shift to Park message when the vehicle has been shifted into Park, and the ignition has been turned to the Off position. Aside from seeing the message, technicians may find DTC B000A set.
<b>Cause</b>	The cause of the condition may be that the park switch in the transmission control (shifter) assembly is not pulling the BCM signal low to electronically show that the vehicle is in the Park position.

Verify the condition and following the steps in the Service Procedure below, install an In-line Shifter Wire Harness Jumper between the shifter base connector and the console harness connector.
