# Service Bulletin

Bulletin No.: 19-NA-216

**Subject: Noise, Vibration, and/or Harshness Issues/Clunk Noise Heard During Coast Down Event**

Brand:	Model:	Model Year:		VIN:		Engine:	Transmission:
		from	to	from	to		
Chevrolet	Silverado 2500/3500	2020	2020			L5P	MGM
GMC	Sierra 2500/3500

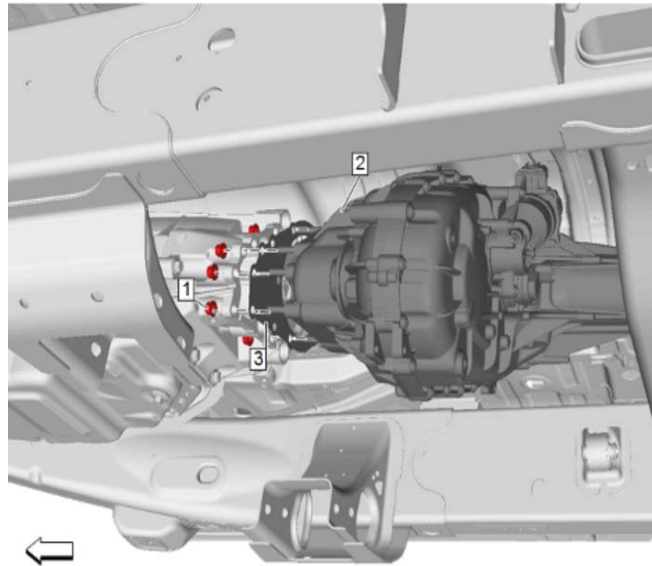
5411622

- If the noise is NOT from the transfer case (2), refer to SI for further diagnostics.
- If the noise has been verified to be from the transfer case, refer to the Service Procedure below.
