Service Bulletin

Bulletin No.: 20-NA-001

Subject: Low Volume Of Air Delivery Through The Defrost Vents During Vehicle Remote Start

Brand:	Model:	Model Year:		VIN:		Engine:	Transmission:
		from	to	from	to		
Cadillac	XT4	2019	2019			All	All

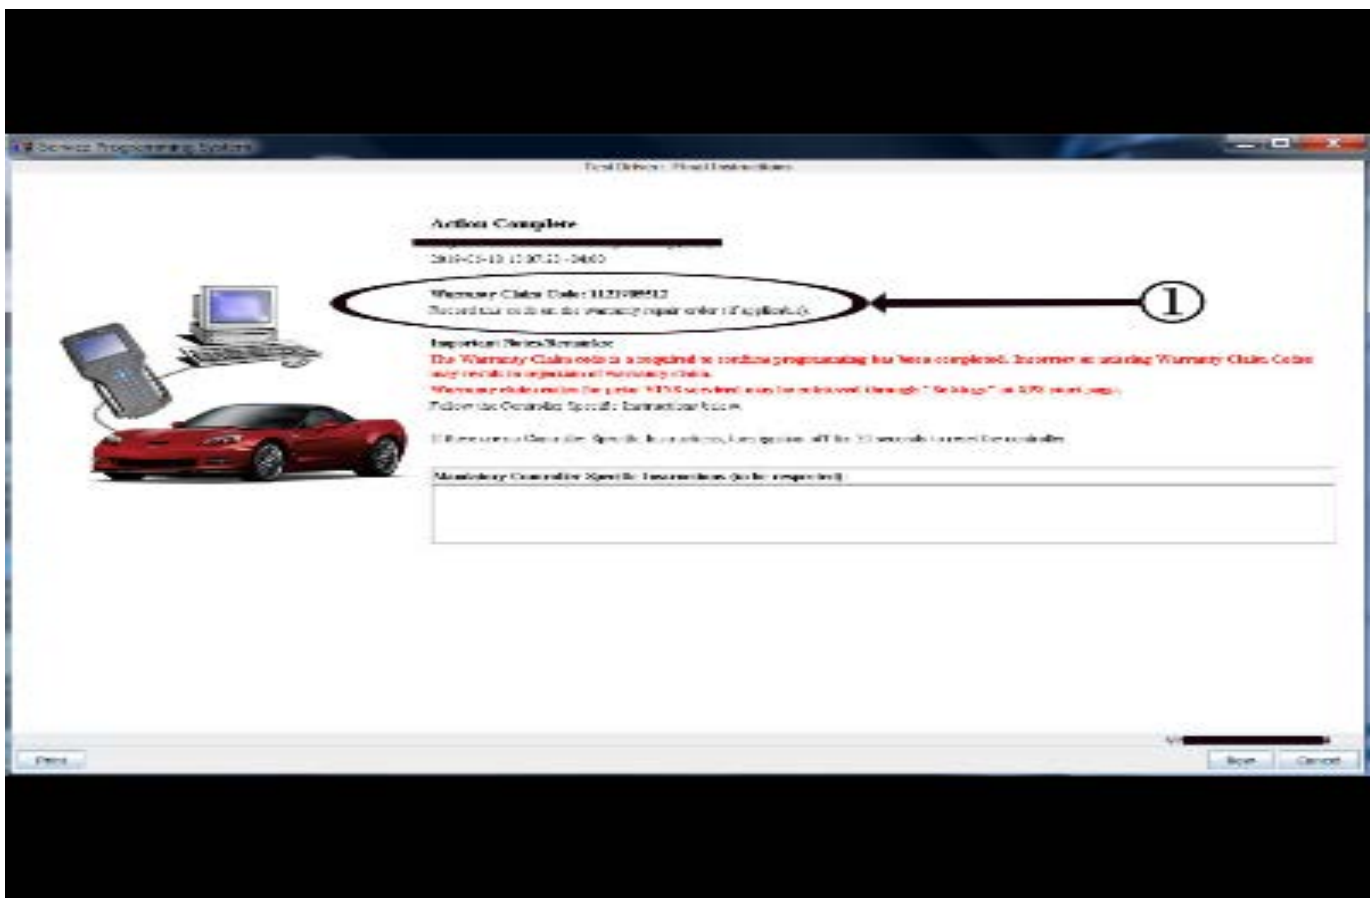
5431209

Note: To avoid warranty transaction rejections, you **MUST** record the warranty claim code provided on the SPS Warranty Claim Code (WCC) screen on the job card. Refer to callout 1 above for the location of the WCC on the SPS screen.

- Record SPS Warranty Claim Code on job card for warranty transaction submission.
