Service Bulletin

Bulletin No.: 20-NA-004

Subject: Metal on Metal Noise after Lower Control Arm Replacement

Brand:	Model:	Model Year:		VIN:		Engine	Transmission:
		from	to	from	to	Engine:	Transmission.
Chevrolet	Trax	2015	2020

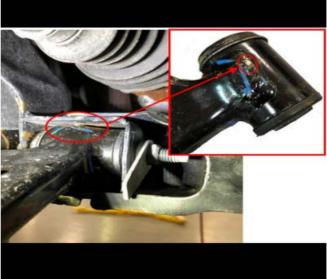
5472801

Involved Region or Country	North America		
Condition	Some customers may comment that a metal on metal noise can be heard when the vehicle is moving.		
	Some technicians may find that the lower control arms have been previously replaced.		
Cause	This condition may be caused by excessive weld of the lower control arm (LCA) coming into contact with the cradle control arm pocket.

Verify control arm contact with the cradle:

- 1. Lift the vehicle. Refer to Lifting and Jacking the Vehicle in SI.
- 2. Remove the front wheel.
- 3. Inspect the lower control arm contacting the cradle as shown in the graphic above.
 - If the control arm is contacting the cradle, replace the LCA.
 - If the control arm is not contacting the cradle. refer to SI for further diagnostics.
