# Service Bulletin

Bulletin No.: 20-NA-011

**Subject: Voice Recognition Launches or Radio Station Changes to an Adjacent Favorite Without Any Button Press**

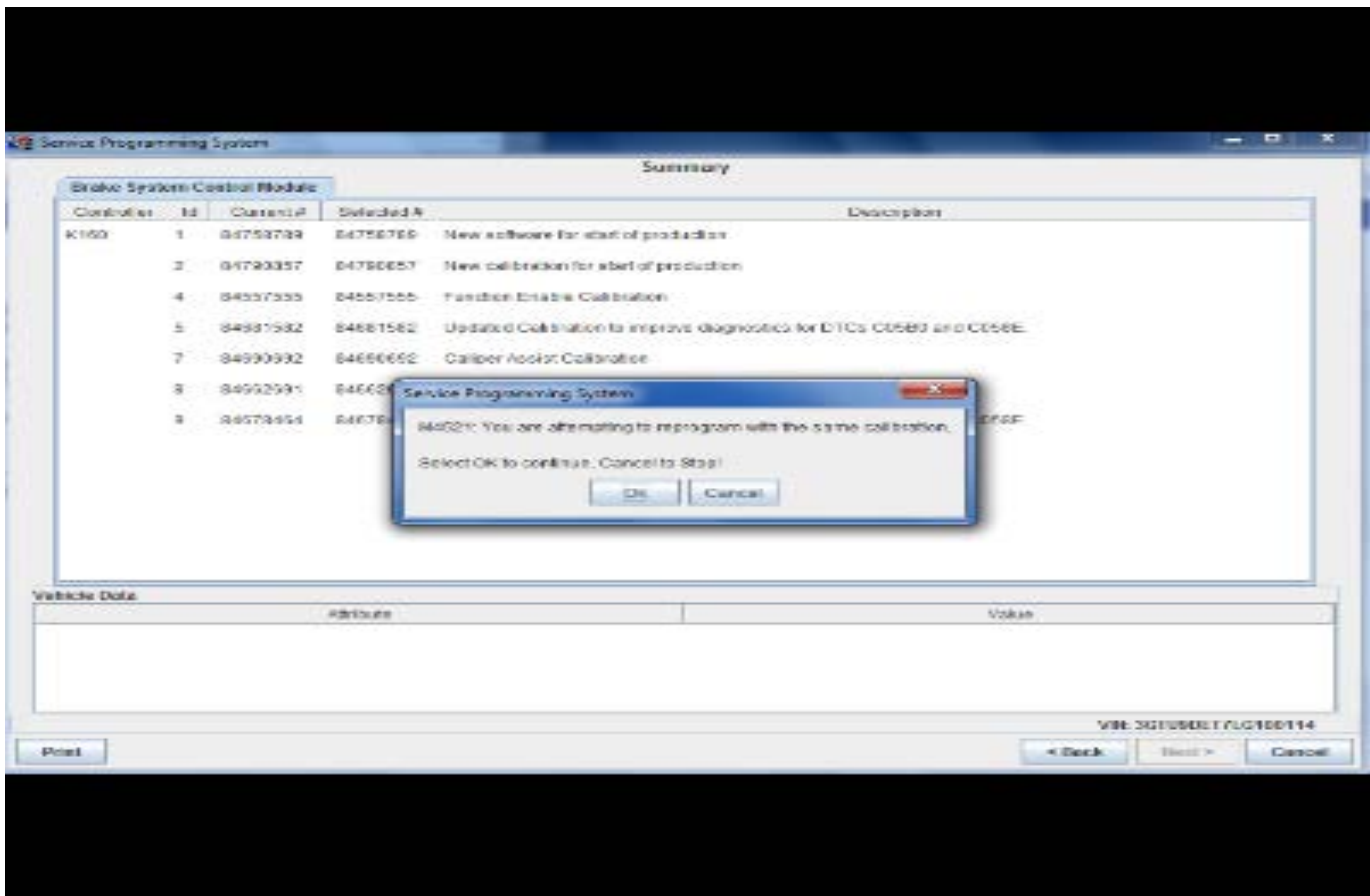
5431207

**Important:** If the Same Calibration/Software Warning is noted on the SPS screen, select OK and follow screen instructions. After a successful programming event, the WCC is located in the Service Programming System dialogue box of the SPS Summary screen. No further action is required. Refer to the Warranty section of the bulletin.

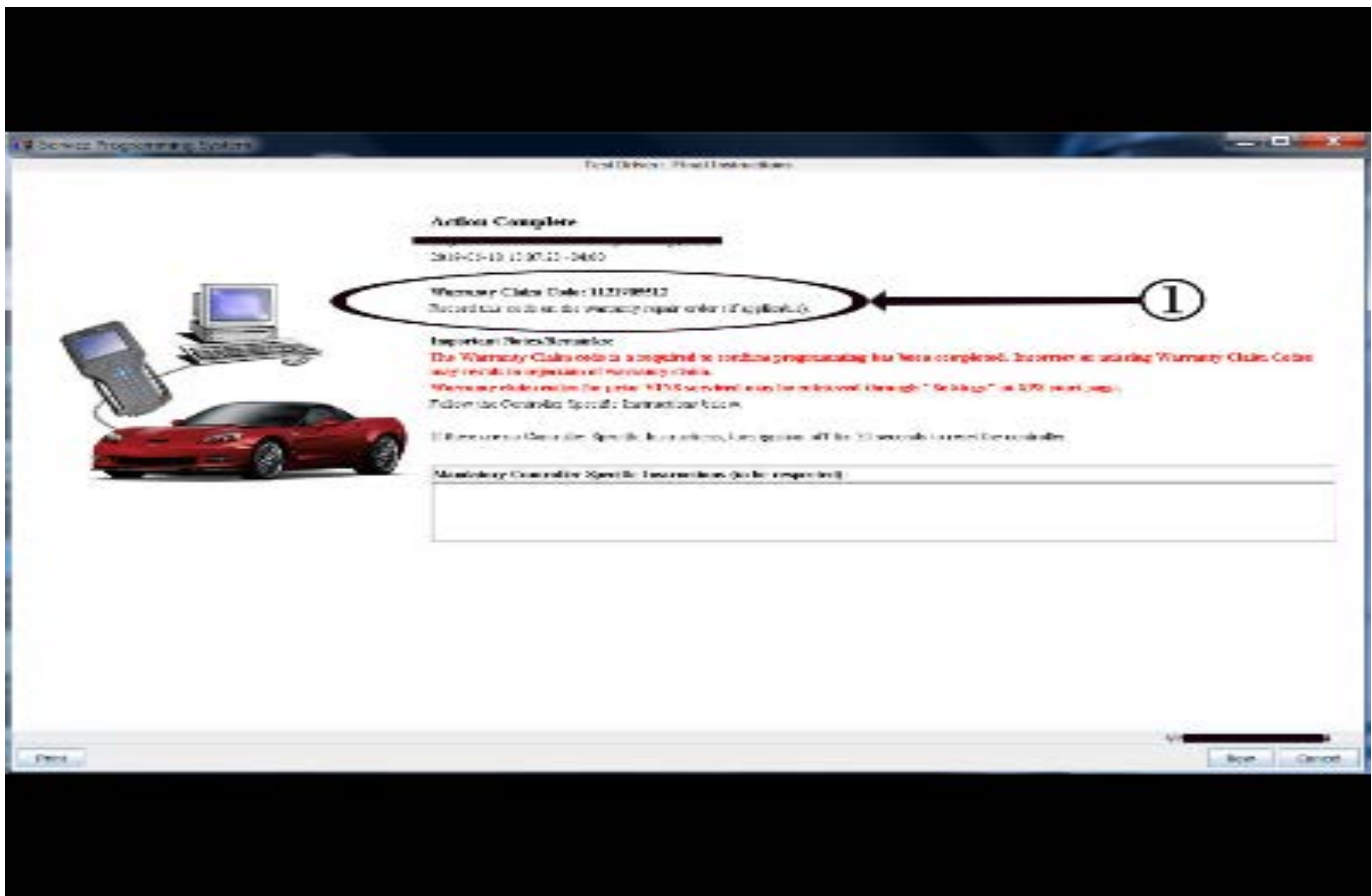
5431209

**Important:** To avoid warranty transaction rejections, you **MUST** record the warranty claim code provided on the SPS Warranty Claim Code (WCC) screen on the job card. Refer to callout 1 above for the location of the WCC on the SPS screen.

2. Record SPS Warranty Claim Code on job card for warranty transaction submission.
