## TECHNICAL SERVICE BULLETIN

### 3.5L EcoBoost - Oil Pan Leaking - Built On Or Before 19-Mar-2018

**20-2051**  
25 February 2020

<b>Ford</b>
2017-2018 F-150
2018 Expedition
<b>Lincoln</b>
2018 Navigator

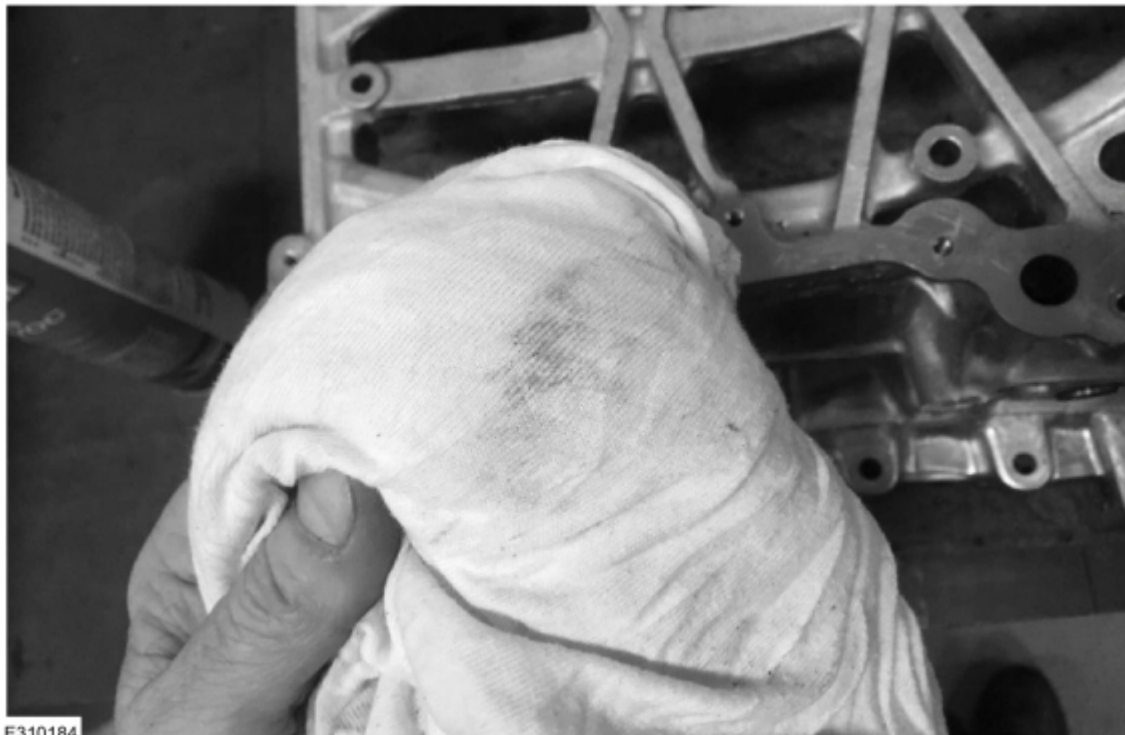
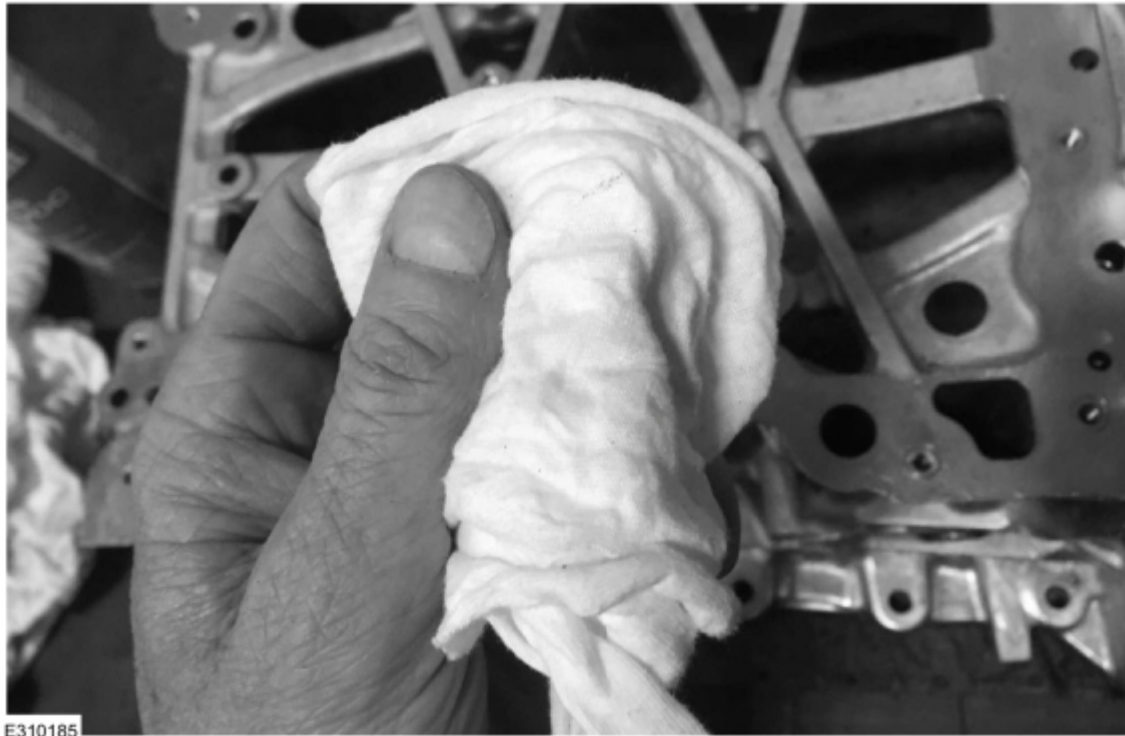
(1). Use only Motorcraft® Metal Brake Parts Cleaner to clean the engine sealing surface. Some unapproved brake parts cleaners contain chemicals that will inhibit RTV adhesion or may evaporate without removing all of the residual oil from the sealing surface which will result in a repeat leak condition.

3. Use a lint free towel and Motorcraft® Metal Brake Parts Cleaner to remove all residual sealant and oil from the engine sealing surface until a clean lint free towel no longer shows any residual oil when wiping the surface. (Figures 1-2)

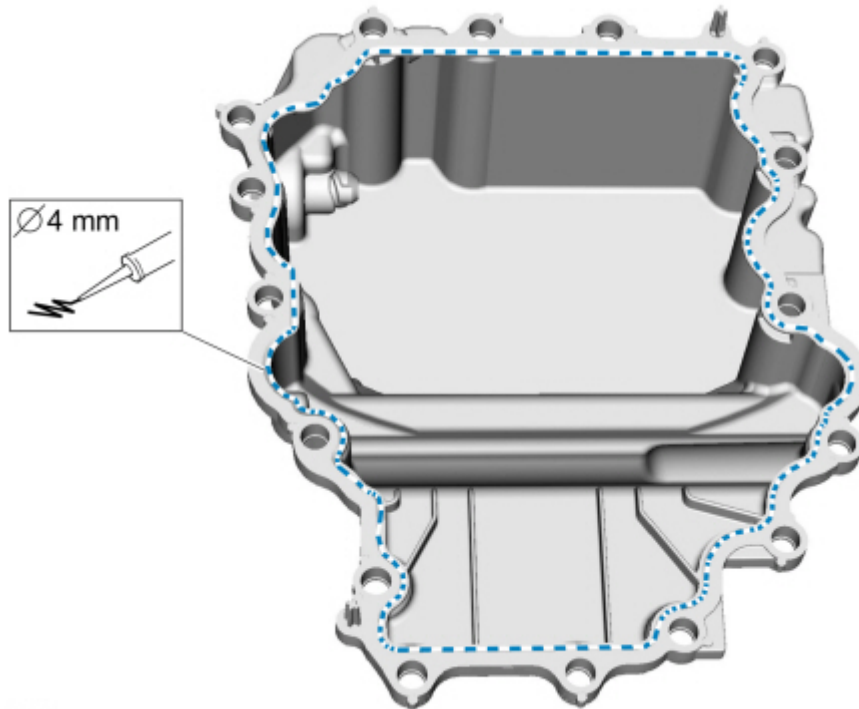
Figure 5

(1). Using too little sealant may result in oil leaks and using too much sealant may result in oil contamination and engine damage.

7. Apply a 4 mm (0.16 in) bead of Motorcraft® High Performance Engine RTV Silicone to the new oil pan. (Figure 5)
