SERVICE INFORMATION BULLETIN

APPLICABILITY: 2019-20MY Forester

NUMBER: 07-142-18R

SUBJECT: Battery Sensor Removal and Installation Precautions

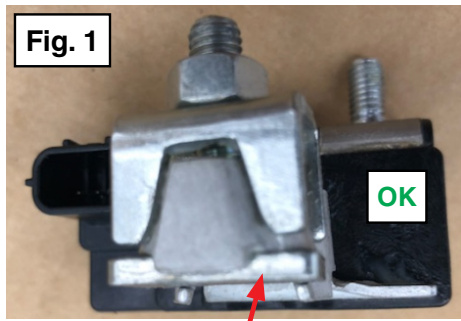
Plate (a) shown in proper position with the rotation stopper tabs (b).

- If the sensor needs to be removed, loosen the 10mm hex nut **only as much as needed** to remove it from the (-) battery post. This way, the bottom plate (a) will stay in the proper position on the underside of the wedge / clamp portion as shown in **Fig. 1** below. If the nut is loosened too far like in **Fig. 2**, the plate can get out of alignment with the rotation stopper tabs (b) as shown in **Fig. 3**. If an attempt is made to reinstall the sensor with the plate out of position, the sensor will be damaged and require replacement.

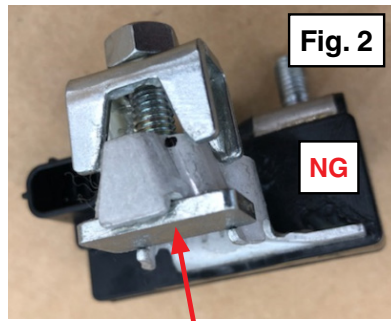
Plate (a) still shown in proper position but, retaining nut loosened too much.

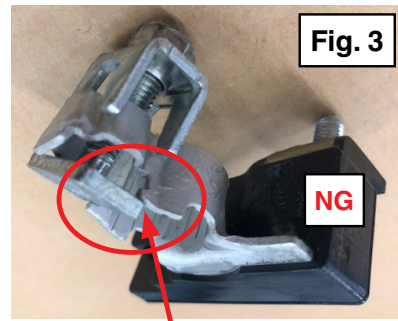
Plate (a) mis-aligned with rotation stopper tabs (b) because retaining nut has been loosened too much.

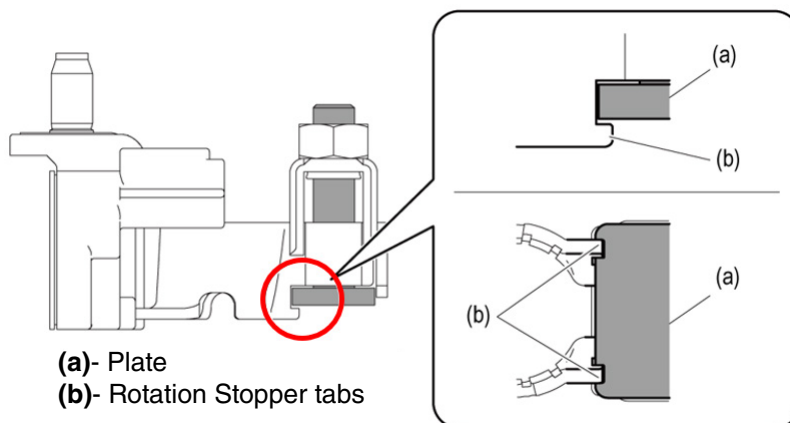
The illustration above provides an additional detail view of how the plate (a) is required to fit into the rotation stopper tabs (b).

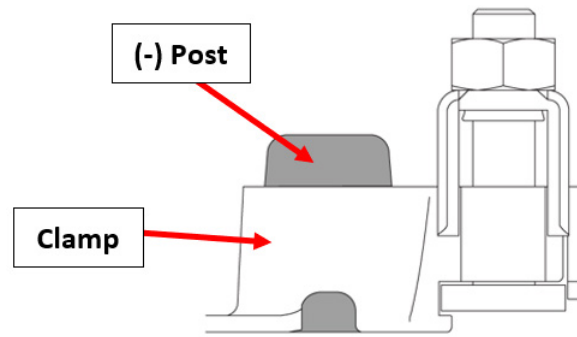
- When installing the sensor assembly onto the battery post, confirm it is fully seated and the (-) post protrudes above the clamp portion as shown below before torquing the 10mm retaining hex nut.

- Negative Battery Cable (Ground) Nut: 7.5 Nm (**5.5 ft. lbs.**)
- Terminal Clamp Nut: 6 Nm (**4.4 ft. lbs.**)
- Always hold the sensor in place with one hand while loosening or torquing either 10mm hex nut.
