**SERVICE BULLETIN**

**APPLICABILITY:** 2015-2017MY Legacy and Outback  
 2015-2017MY Impreza and XV Crosstrek  
 2015-2018MY Forester  
 2016-2018MY WRX  
 2015-2017MY BRZ

**NUMBER:** 15-199-16R  
**DATE:** 05/05/16  
**REVISED:** 02/19/20

**SUBJECT:** Reprogramming File Availability to Address Operational Concerns with 6.2” Clarion Display Audio Unit

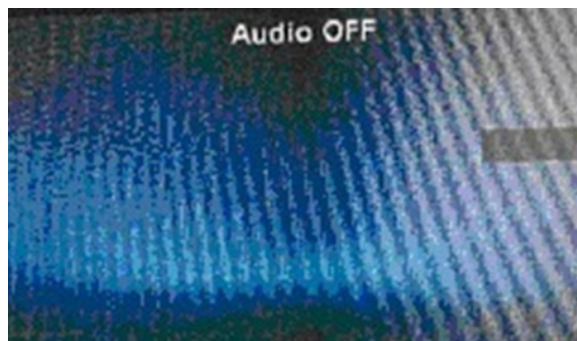
- Audio unit freezes and restarts when inserting and removing USB memory (flash drive).
- CD player stops playing audio and / or elapsed time display freezes.
- While talking on a paired phone and using the Bluetooth feature, audio unit restarts when shifting into Reverse.
- Audio unit restarts when receiving a Bluetooth phone call. The display goes black and may be accompanied by a “popping” sound.
- White stripes or streaks appear on the display as shown below.

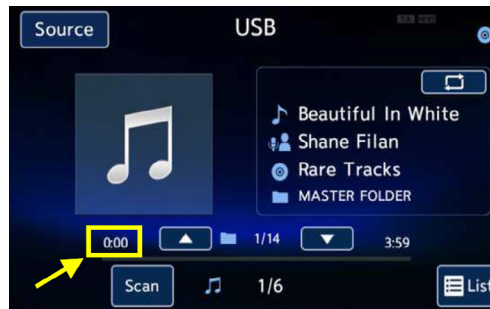
- When listening to music from a USB drive, the elapsed play time counter stays at 0:00.

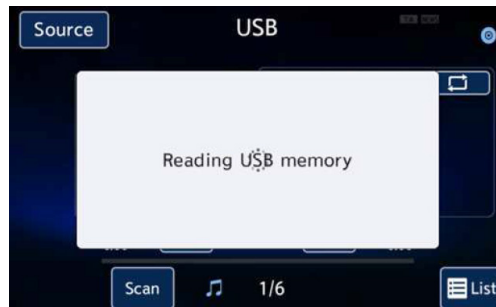
- When listening to music from a USB drive, the music plays normally but the screen display shows “Reading USB Memory”.

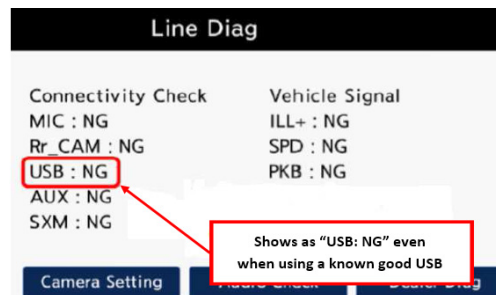
- In diagnostic mode, “USB: NG” is displayed even though a known good USB drive is plugged in.

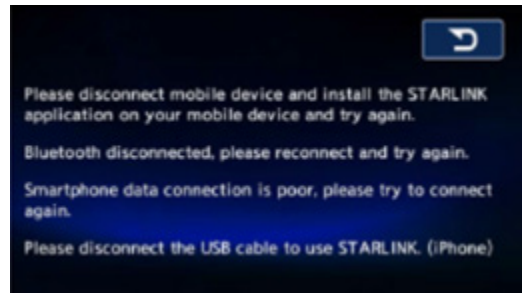
- When using the Magellan Navigation smartphone application (Release date 11/1/2016) for approximately 6 hours, the Bluetooth disconnects and the route guidance screen freezes. An error message screen displays asking the user to disconnect their mobile device, install the STARLINK application on their mobile device and try again along with three other connection-related messages.

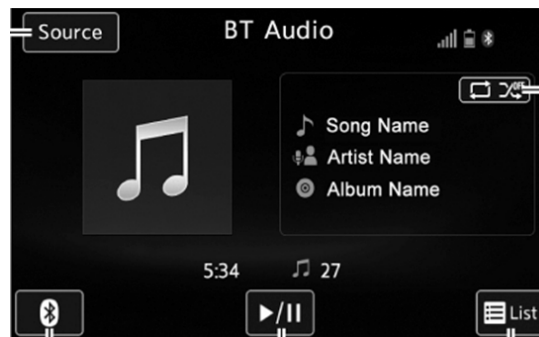
- All the function keys such as the steering switch, hard keys on the head unit and touch panel (display) become inoperative after playing music for 3-4 hours using a Bluetooth-connected device and no input from any of the keys on that connected device. When this occurs, music continues to play normally but the display screen freezes.

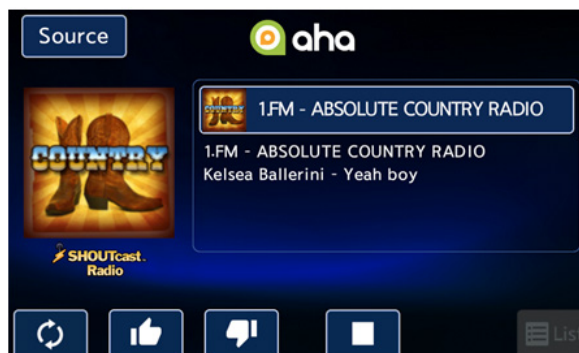
- ✓ When making a hands-free call using the voice command function, the ring-back tone is not heard from the speakers.
- ✓ When making a hands-free call using the voice command function, the user enters the number using the phone's buttons but, a dial tone is not heard from the speakers.
- ✓ When receiving a call using the hands-free and voice command functions, the ringtone is not heard from the speakers.
- When using the ahaRadio feature, song title and artist information does not update after the previous song ends.
