SERVICE BULLETIN

APPLICABILITY: 2019-20MY Impreza
 2019-20MY Crosstrek (Including Hybrid Model)
 2019-20MY Forester
 2019MY Legacy/ Outback
 2019-20MY WRX
 2019-20MY BRZ- Navigation -equipped ONLY
 2019-20MY Ascent

NUMBER: 15-236-18R

SUBJECT: Reprogramming File Availability for Optimization of Harman Gen 3.1 Audio and Navigation Head Units

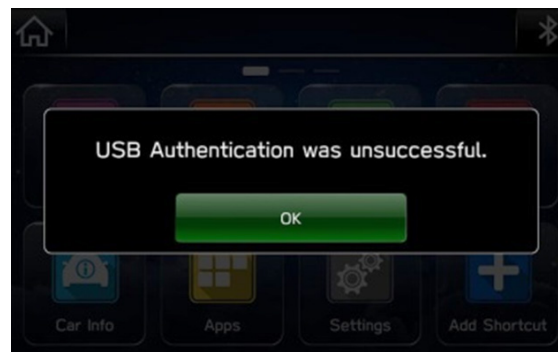
NOTE: If an attempt is made to install the wrong “grade” file into the wrong grade head unit (EXAMPLE: “Base” update file into a “Base Plus or Mid” or “High” head unit), the USB Authentication error screen below will be displayed:

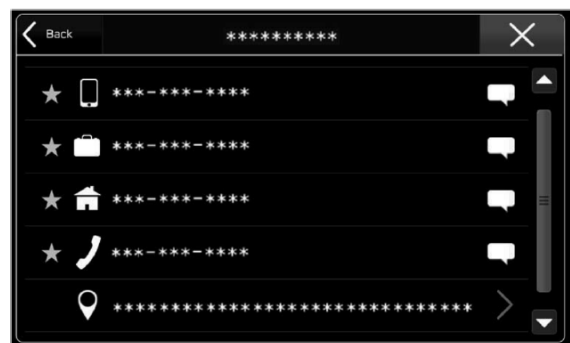
- 1) AM/FM radio station presets are lost.
- 2) Favorite Phone Contacts list is lost.

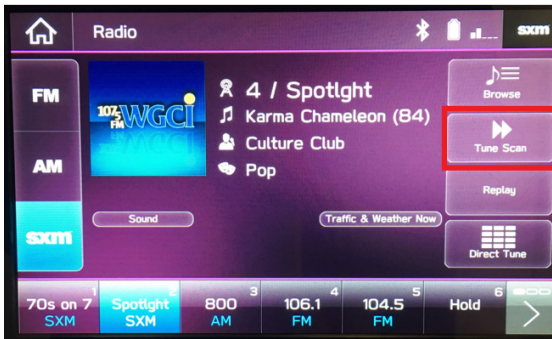
3) <Scan> previously displayed on SXM screen was changed to <Tune Scan> (a.k.a. SEEK).

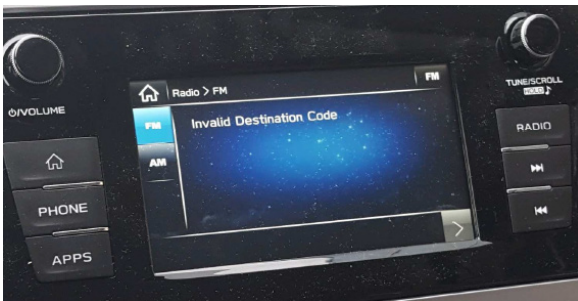
- 4) US State names corrected when using voice guidance.
- 5) Correction made for Pop / Crackling-type sound when using AM radio.
- 6) Navigation system freezes during loading / start-up.
- 7) Music skips/cuts out while using Apple CarPlay.
- 8) Hands-free feature freezes intermittently while loading.
- 9) Navigation system freezes after entering a particular address using Voice Recognition.
NOTE: All other functions are not affected.
- 10) The voice guidance volume no longer changes After Ignition Off/On. Once the Voice Guidance has been muted, the system retains that setting even after switching the ignition Off/On.
- 11) Invalid Destination Code message appears on the display while listening to the radio.

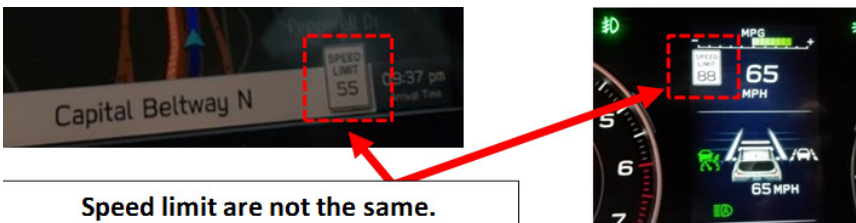
- 12) Spanish version FOTA (Firmware Over The Air) translation corrected.
- 13) Mismatch of Speed Limit between Navigation display and the Speed Limit displayed in the Combination Meter Multi-Function Display (MFD).

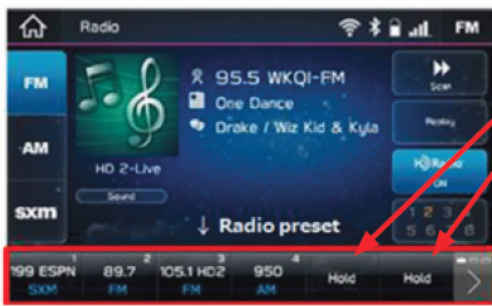
- 1) Station presets are lost. Touch buttons read “Hold”. (Applicable for software versions Rel_4.18.25.50 (or before)). Included in software version Rel_U1.18.38.50.
