**SERVICE BULLETIN**

**APPLICABILITY:** 2020MY Ascent

**NUMBER:** 15-260-20

**SUBJECT:** Harman Display Audio and Navigation  
-Equipped Head Unit Operational Concerns due to Configuration Issues

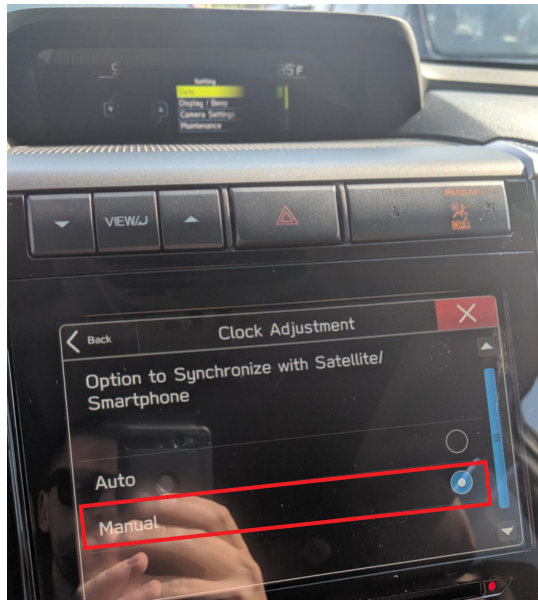
- Unable to use the Map Over The Air (MOTA) update feature via smartphone
- After selecting Manual from the Clock Adjustment screen shown below, the user is unable to adjust the clock time display manually.

To restore the functionality of these features, the head unit must be replaced with the applicable exchange audio head unit as reprogramming cannot correct these concerns.
