Articles Contained in this Issue

TECH TIPS GREATEST TIPS

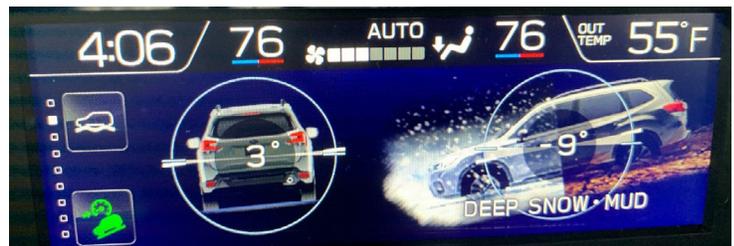
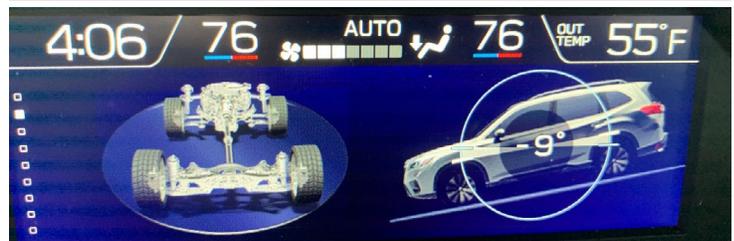
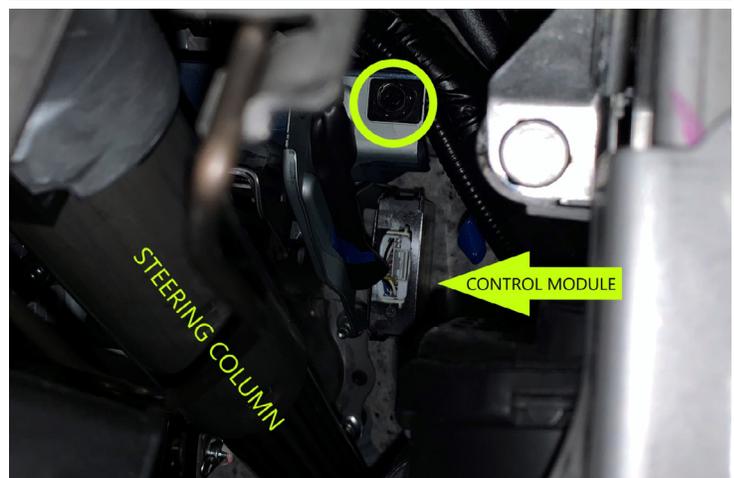
07 2019MY and up Forester MFD Displays Incorrect Vehicle Angle

Technicians have been encountering a customer concern of the MFD is always displaying the vehicle pitch and/or yaw at a value other than 0 degrees even when parked on a seemingly level surface. Diagnosis for this concern should start with examining the Auto Headlight Beam Leveler Control Module.

The MFD receives this information from the Auto Headlight Beam Leveler Control Module. The Headlight control module installation is key for proper operation. The module is located above the steering column in the driver's front footwell area. Check the mounting bolt and bracket to ensure both are secure, and the bracket has not been moved, bent or otherwise damaged.

After determining the mount is properly installed, make sure to complete the reinitialization procedure. This can be found in **Body & Electrical/Wiring** > **Lighting System** > **Auto Headlight Beam Leveler System** > **Procedure**.

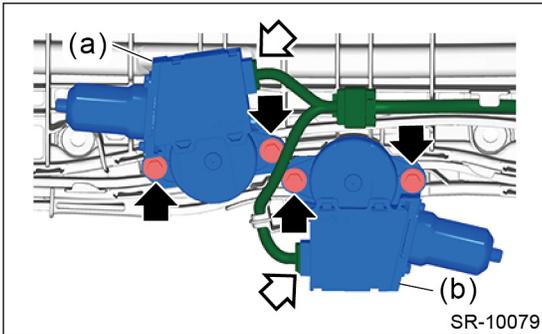
(a) Motor ASSY shade
(b) Motor ASSY lid

When replacing a sunroof frame, or during any sunroof diagnosis, it is imperative to ensure the sunroof and sunshade motors are installed correctly. The motor for the shade and the glass look interchangeable but, this is not the case as there are distinct internal differences. Also, the connectors for the motors are the same shape which allows them to be easily installed incorrectly. Refer to the Service Manual to ensure the correct motor is installed to each location and the correct connector is plugged in to each motor.

Go to **Body & Electrical/WIRING SYSTEM**
> **SUNROOF/T-TOP/ CONVERTIBLE TOP**
(SUNROOF) > **Sunroof Motor** > **REMOVAL** for
motor identification.

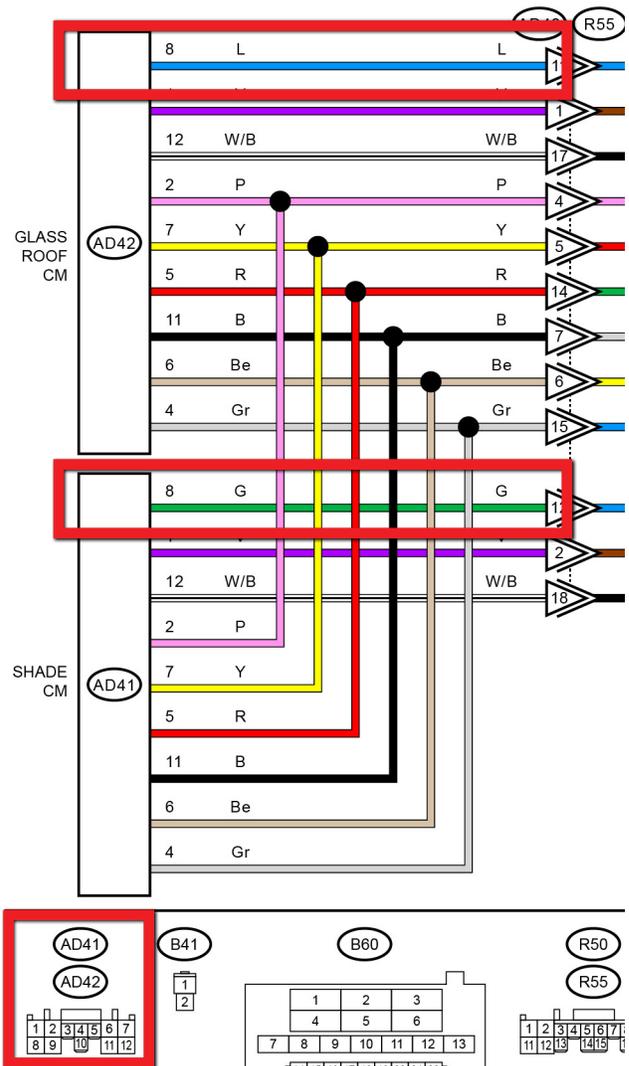
AD41 and AD42 are the connectors for the sunshade and sunroof motors. Notice the wire colors and pin positions are identical, except pin number eight. AD41 pin eight has a green wire whereas AD42 pin eight has a blue wire.

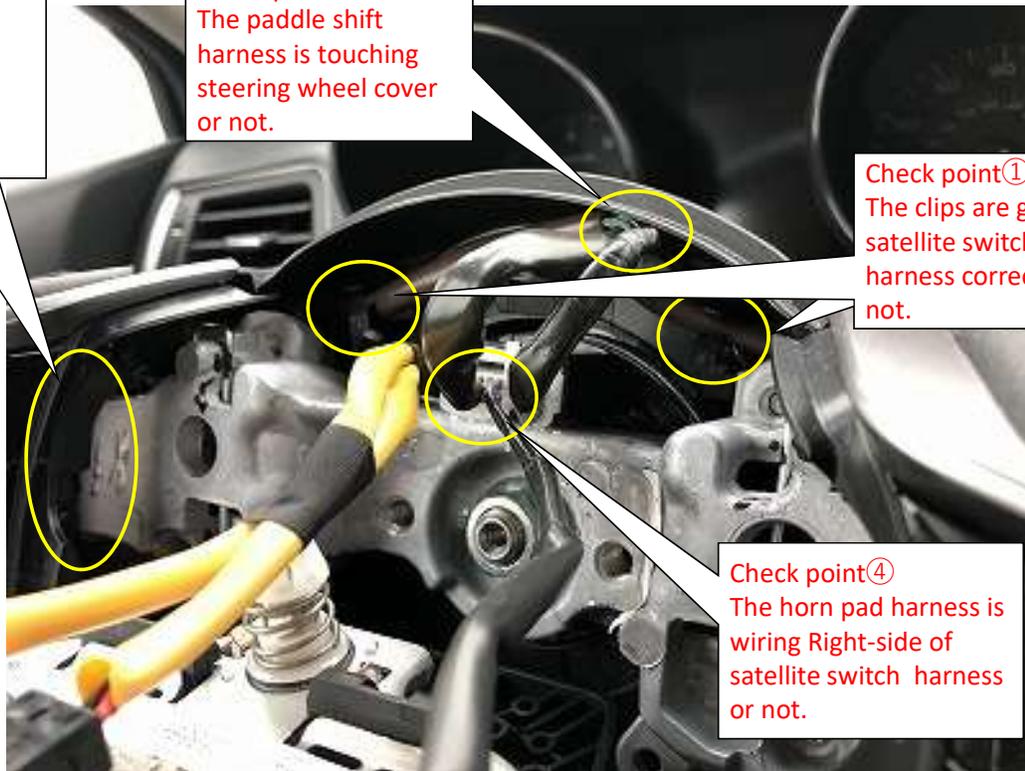
12 Rattle Sound from Steering Wheel Area

Late model Subaru vehicles have many different components installed to the steering wheel. Each component has its respective wiring harness. When diagnosing a customer's concern of a rattle noise coming from the steering wheel area it is important to confirm the wiring harnesses are routed correctly. Use this check point guide to confirm all wiring harnesses are routed appropriately.

Check point③
The harness is stuck between steering wheel and satellite switch cover or not.

Check point②
The paddle shift harness is touching steering wheel cover or not.

Check point①
The clips are grabbing satellite switch harness correctly or not.

Check point④
The horn pad harness is wiring Right-side of satellite switch harness or not.

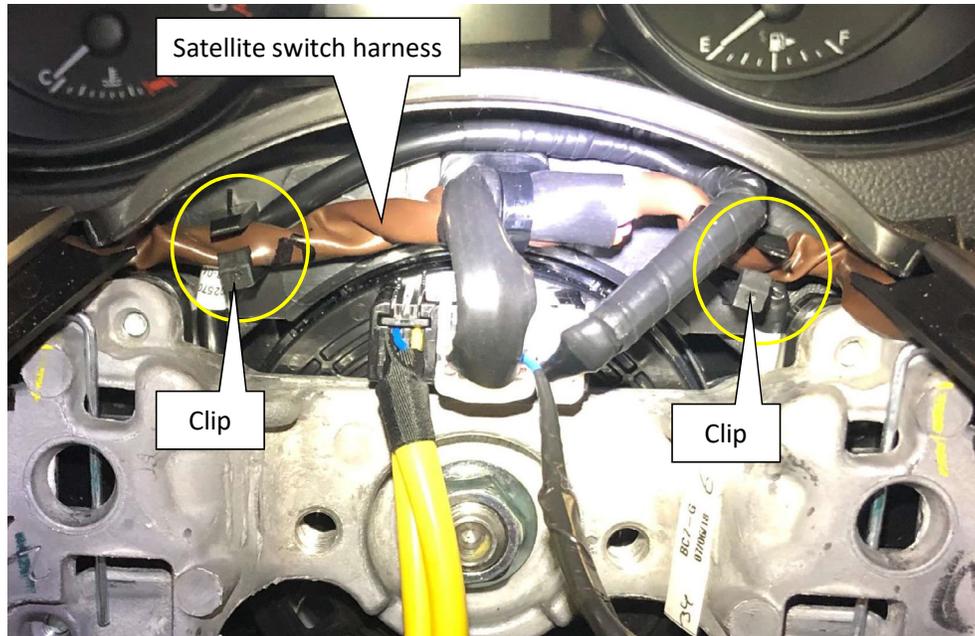
CHECK POINT ①

- The satellite switch harness (brown) is secured by two clips. Make sure the harness is fully installed into each clip as shown below.

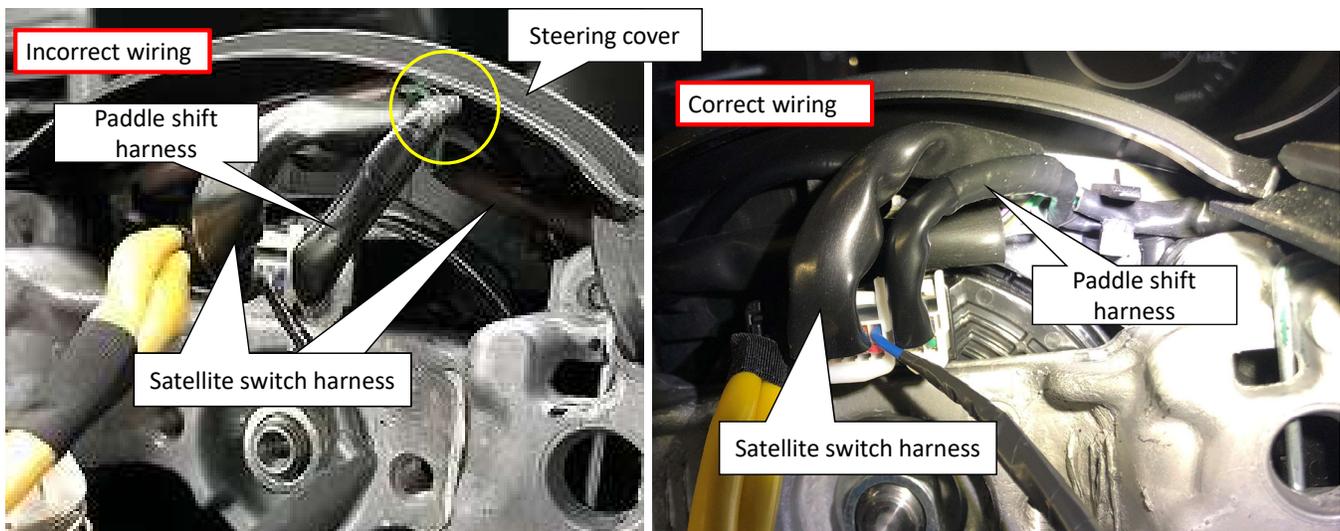
CHECK POINT ②

- Make sure the paddle shift harness is touching with steering cover or not.
- The paddle shift harness should be routed below the satellite switch harness. If the paddle shift harness is touching the steering column cover re-route the paddle shift harness below the satellite switch harness.
- If the paddle shift harness is still touching the steering column cover after correcting the harness routing, please install non-woven tape or EPT foam tape on the paddle shift harness to prevent a possible rattle sound.

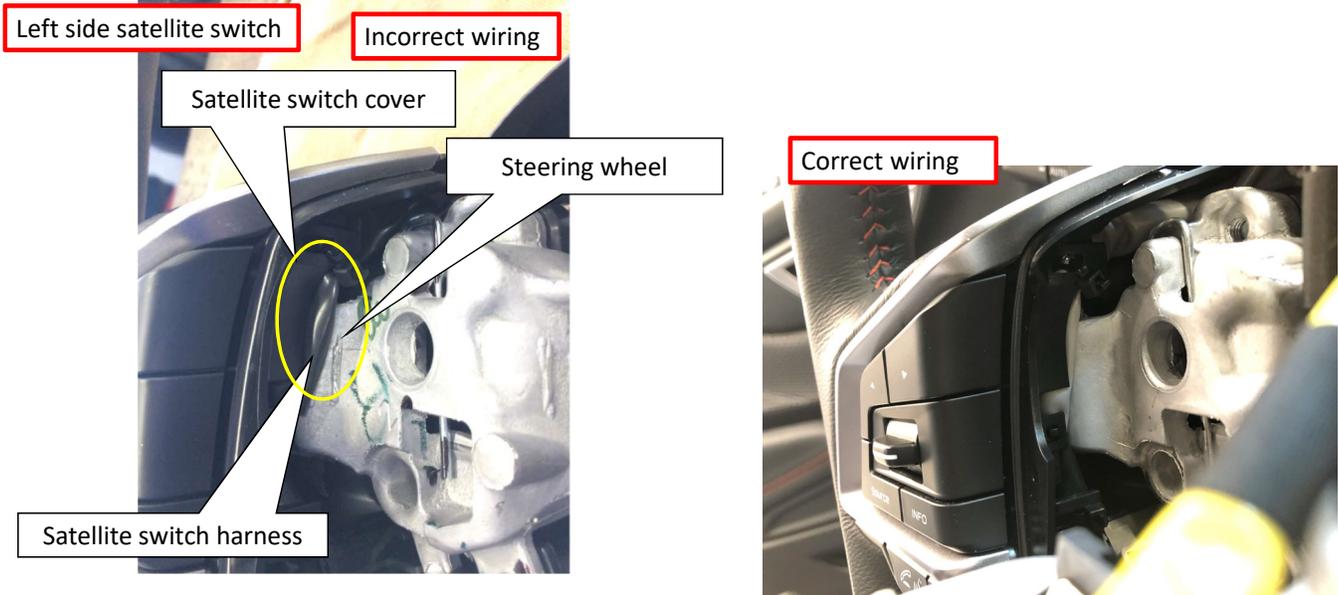
CHECK POINT ③

- Check to see if the satellite switch harness is stuck between the steering wheel and the satellite switch cover.
- If the satellite switch harness is stuck there, push the satellite switch harness back into the satellite switch cover. Always be sure to check BOTH satellite switches.

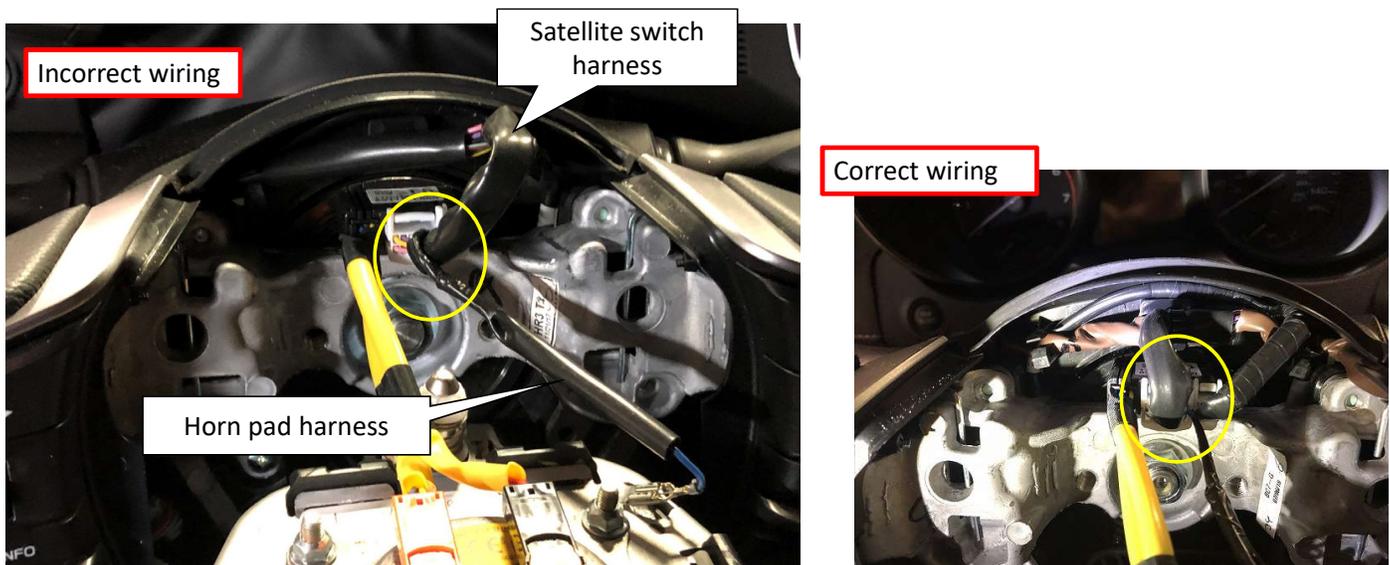
CHECK POINT ④

- Confirm horn pad harness wiring runs to the right side of the satellite switch harness or not.
- If the horn pad harness wiring is on the LEFT side of the satellite switch harness, move it to the right side of the satellite switch harness.

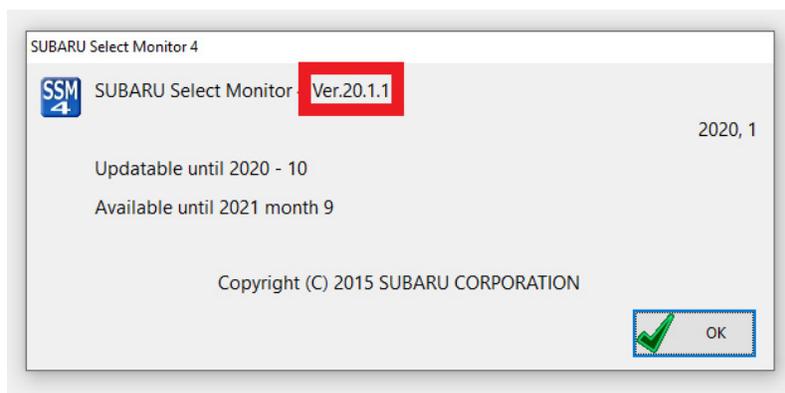
The SSM4 version number is listed as “Ver.xx.x.x” and is displayed in the red box in the photo below.

If your version is before 20.1.1 it needs to be updated (as of February 2020.) Please contact Nuspire at: **(844) 782-7404** for update assistance.

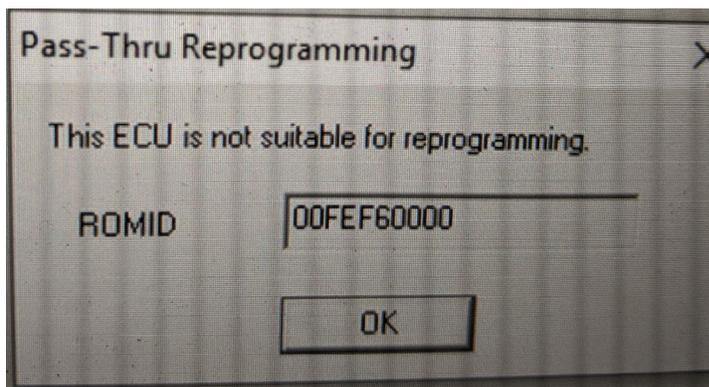
“NOT SUITABLE FOR REPROGRAMMING” MESSAGE

If you encounter a ‘Not Suitable for Reprogramming’ message during a reprogramming session, verify there are no DTCs stored. The Techline has received numerous calls with this concern. After verifying the correct PAK file had been selected and getting the ‘Not Suitable’ message, a P-code was found stored in ECM memory. After addressing the DTC and clearing the memory, the update completed normally.

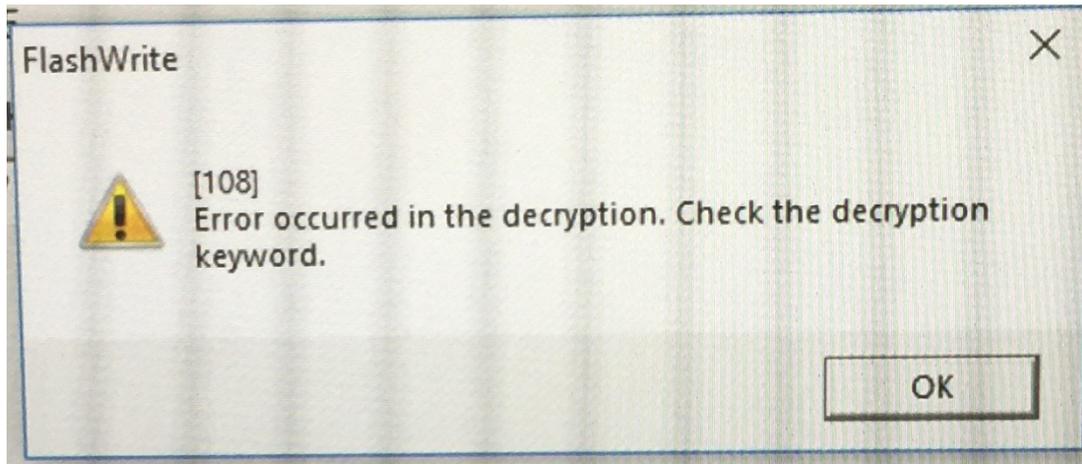
“ERROR OCURRED IN THE DECRYPTION. CHECK THE DECRYPTION KEYWORD” MESSAGE

Error code 108 occurs when the Decryption Keyword is not entered correctly or when the incorrect PAK file is selected. If you get Error 108, first ensure you are entering the decryption keyword as it is written as they are, case sensitive. If you are sure you have entered the correct Decryption Keyword, ensure you are using the correct PAK file. Sometimes, a database error may occur and provide the incorrect PAK file. To make sure this is not the case, try searching by the Vehicle Specification if you initially searched by CID, or search by CID if you initially searched by Vehicle Specification. If you find the PAK number differs based on the type of search, submit a QMR with screenshots or photos of the condition.

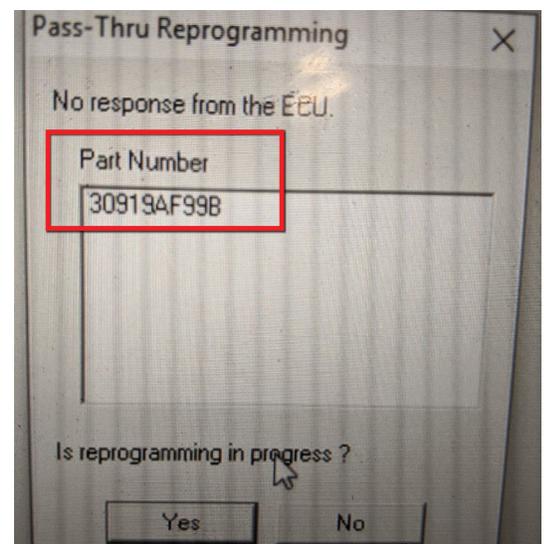
1. Turn the ignition switch to the “OFF” position for at least 15 seconds.
2. Turn the ignition switch back to the “ON” position and restart FlashWrite®2.
3. Proceed with the appropriate file selection for the vehicle specification.
4. Once FlashWrite®2 begins to communicate with the vehicle, the following message will be displayed with the appropriate control module part number displayed:

Click on the part number to highlight it. **THIS IS VERY IMPORTANT.**

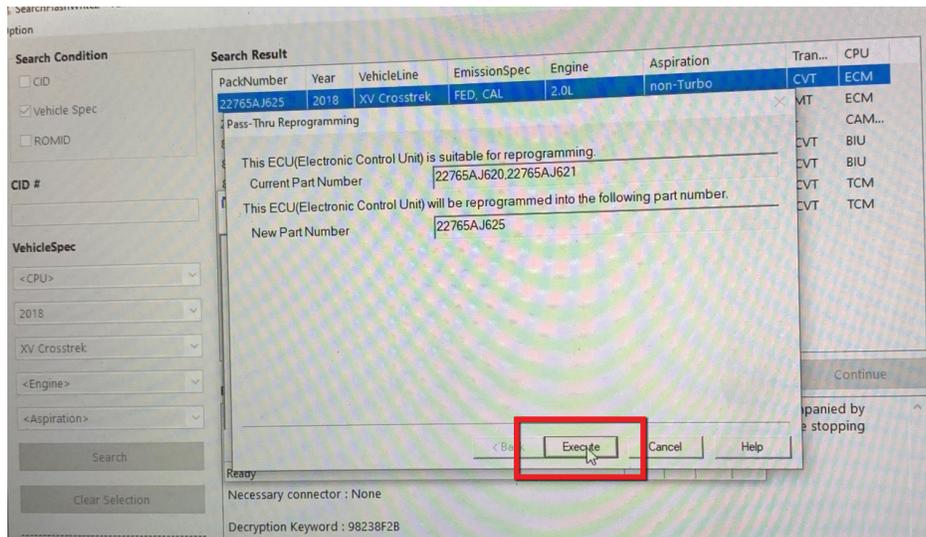
5. Select “Yes” and FlashWrite®2 will show the current and new control module part number screen.

6. Select “Execute” and FlashWrite®2 will begin the reprogramming process.
7. If you incorrectly answer the “Is reprogramming in process?” question “NO”, you will receive error code 4007 “No response from the ECU. Check the cause of no response.”
8. If this is the case, turn the ignition switch off for at least 15 seconds and begin the recovery process again.
