SUBJECT: NEW VEHICLE DEMONSTRATION / DELIVERY HOLD

Customer Satisfaction Program 19B40

Certain 2009-2016 Econoline Shuttle Bus Vehicles Equipped with a 5.4L Engine and 5R110W Transmission (Transporting Limited Mobility Individuals)
Coast Clutch Cylinder and One-Way Clutch Replacement

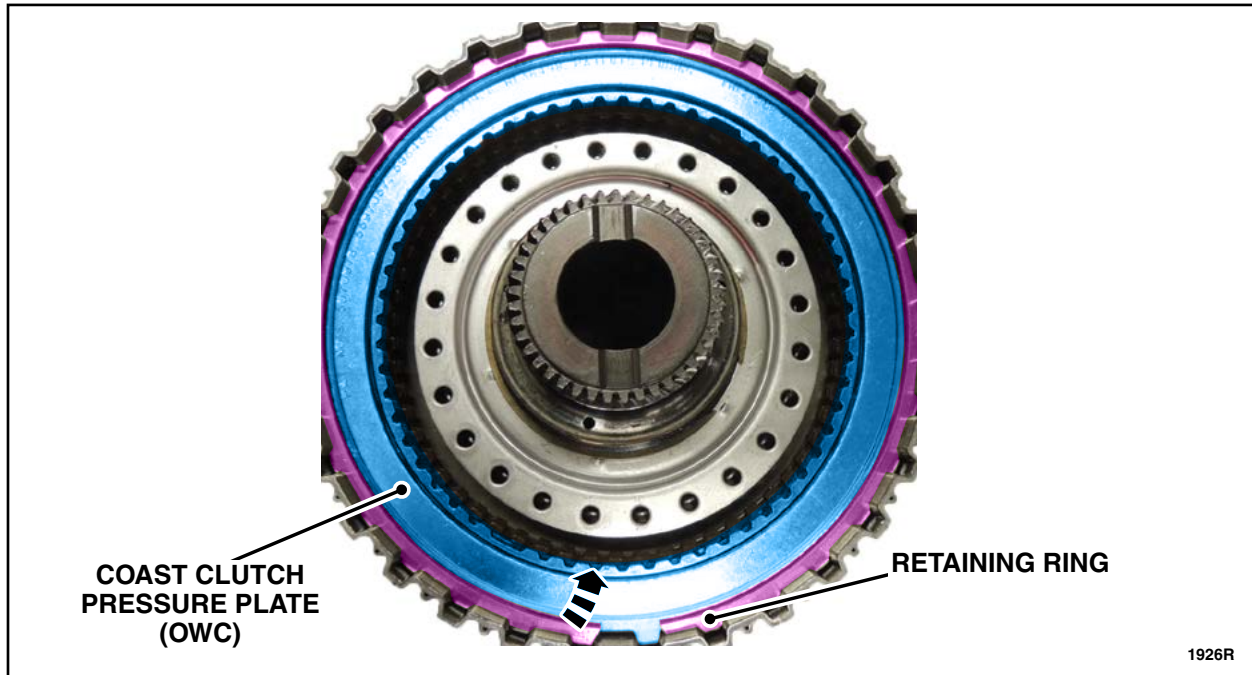
FIGURE 18

17. Remove the retaining ring from the coast clutch pressure plate One-Way Clutch (OWC).
See Figure 18.

26. Install the coast clutch pressure plate OWC retaining snap ring. See Figure 18.

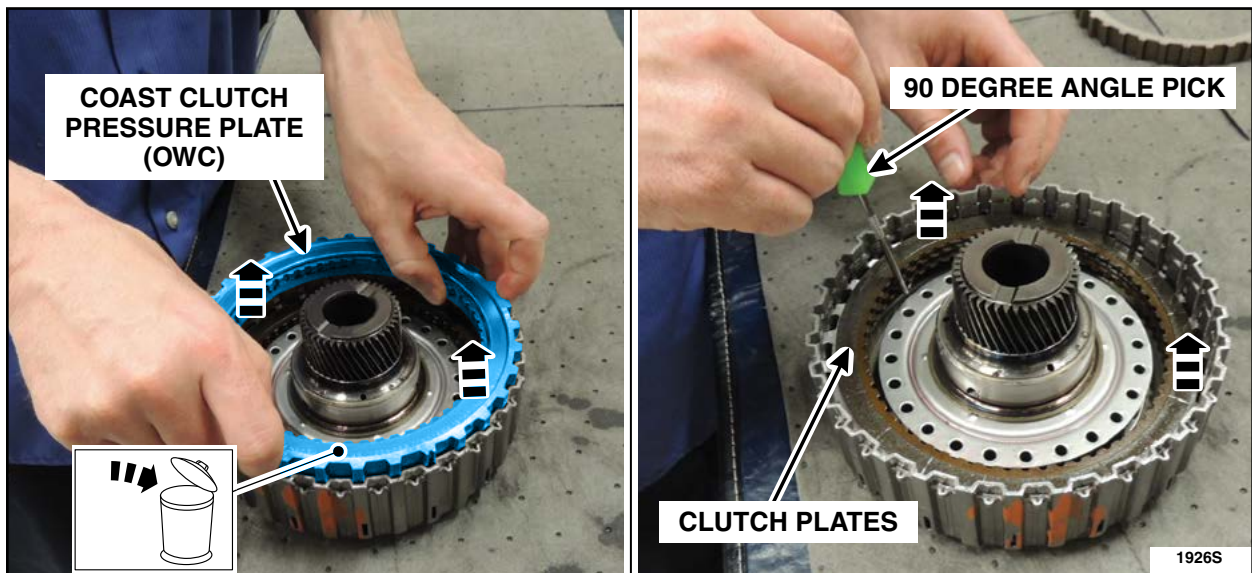
FIGURE 19

18. Remove and discard the coast clutch pressure plate OWC assembly. Then remove the clutch plates and set them aside to be installed into the *new* coast clutch cylinder assembly later in this procedure.
See Figure 19.

25. Install the *new* coast clutch pressure plate OWC assembly and the clutch plates starting with the externally splined steel clutch plate. See Figures 19, 28a and 28b.

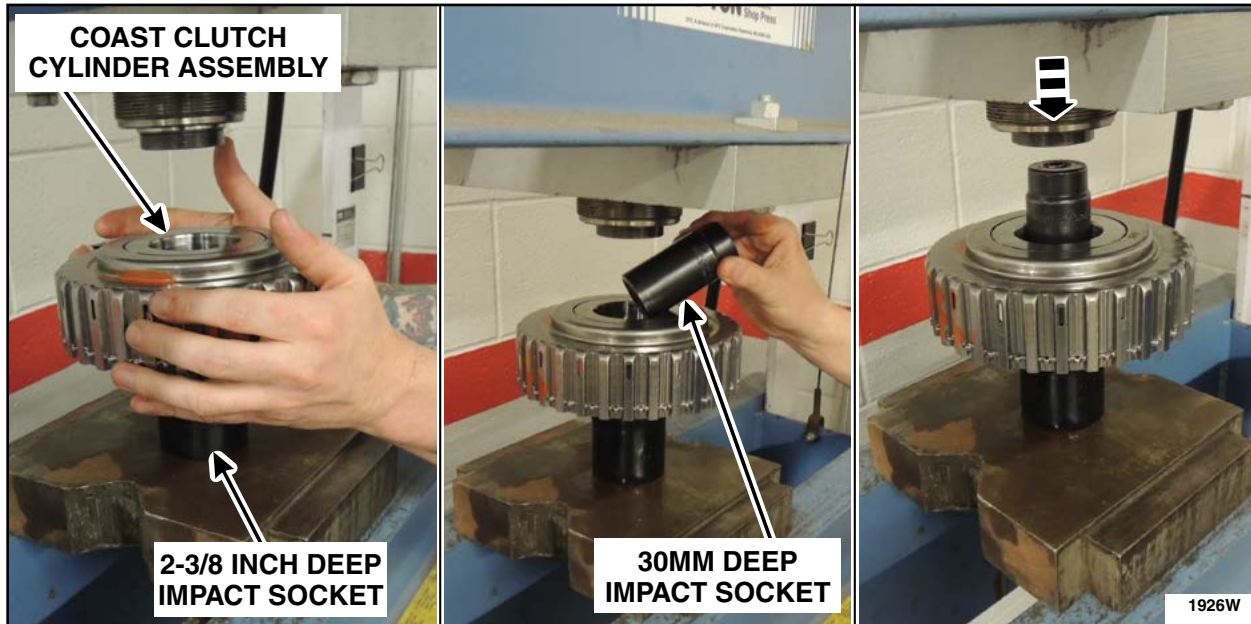
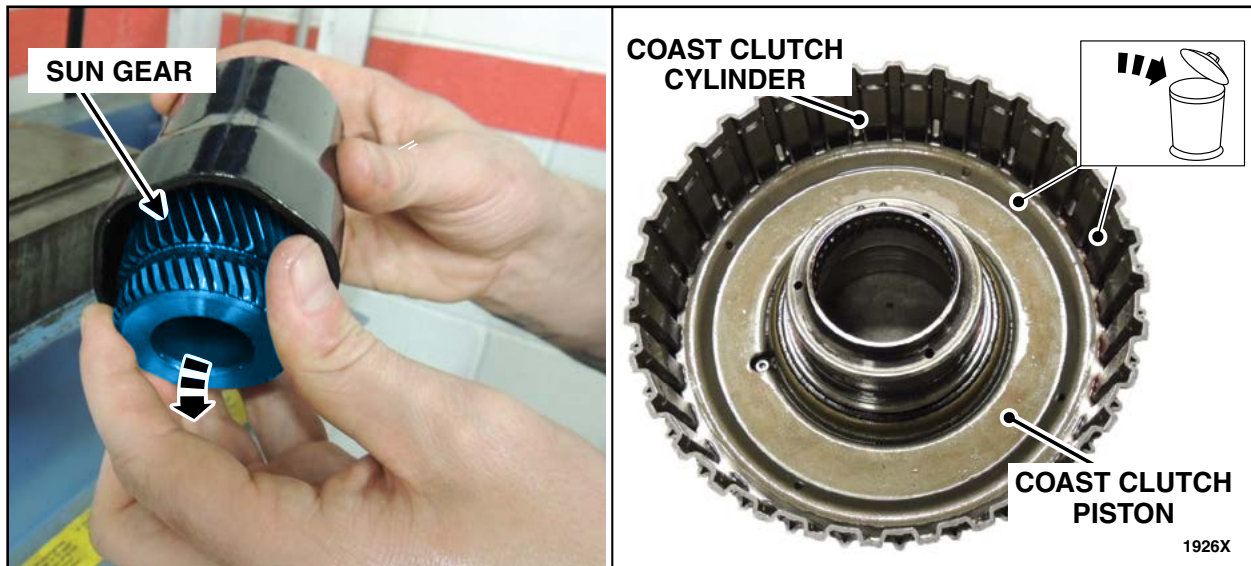
21. Using an arbor press, V-block plate and impact sockets, remove the sun gear. Discard the original coast clutch cylinder assembly and piston. See Figures 23 and 24.
