## Technical product information

| <b>Topic</b> | DTC P04F000 EVAP system high pressure purge line performance DTC logged |

### Bentayga Kovomo 4.0 TSI

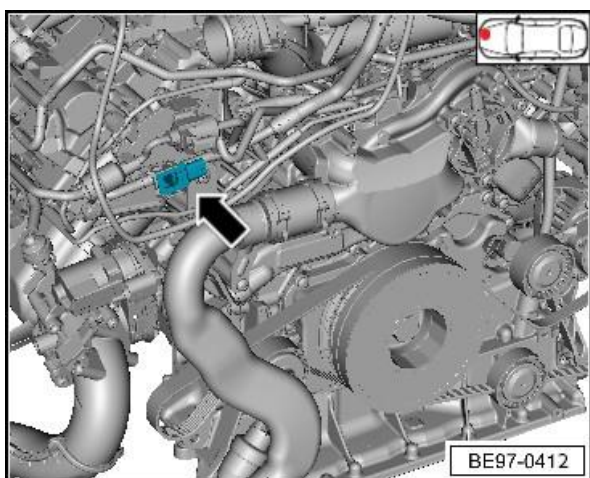
Figure 2

The DTC is related to mismatched terminal locations of the Pressure sensor for the activated charcoal filter system – G804 (Figure 2)
