# Technical Service Bulletin

<b>Topic</b>	Continental GTC - Hood insulation pad tension strap fitting procedure
<b>Market area</b>	Bentley: worldwide (2WBE)
<b>Brand</b>	Bentley
<b>Transaction No.</b>	2058277/2
<b>Level</b>	EH
<b>Status</b>	Released for publishing
<b>Release date</b>	Feb 3, 2020

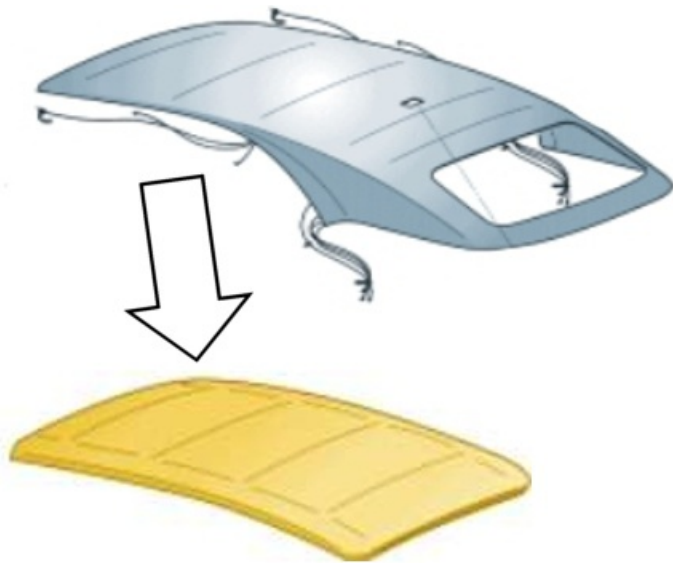
Figure 1

In the event the insulation pad (ARROW - Figure 1) requires replacing, the onward instructions within this TPI must be followed

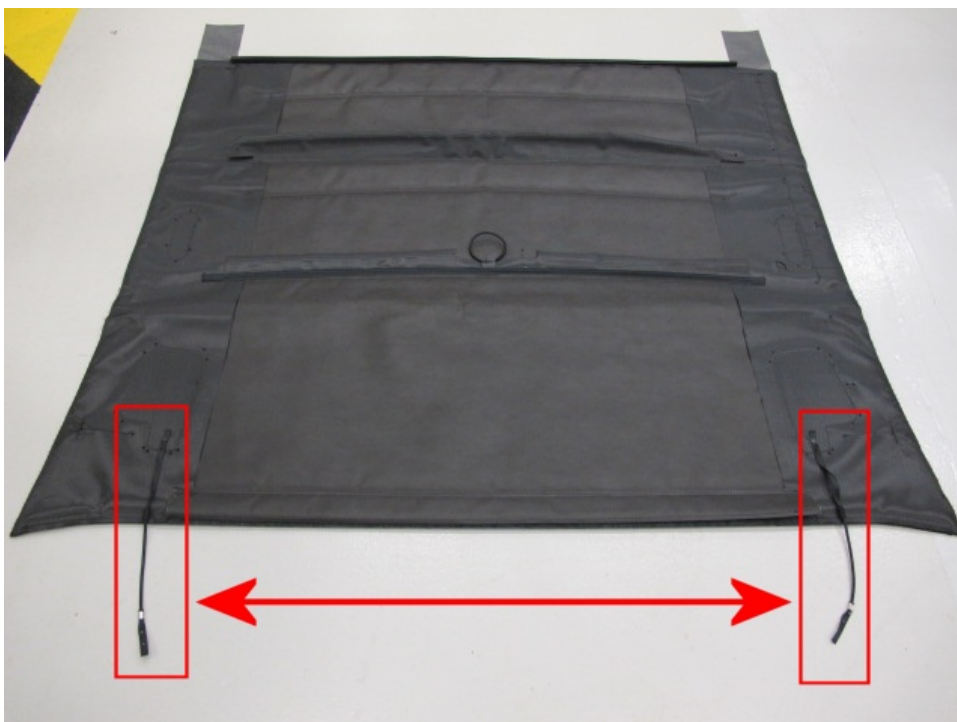
Figure 2

The right and left hand tension straps (Figure 2) are no longer fitted at the time of manufacture, the Measure section within this TPI details the procedure which must be followed to fit the tension straps
