Technical Service Bulletin	Transaction No:	2045672/6
60-18-03 - Water Leak From Rear Of Panoramic Sunroof		Release date:	2/27/2020

Applicable Vehicles					
Model(s)	Year	Eng. Code	Trans. Code	VIN Range From	VIN Range To
Golf Sportwagen, Alltrack	2015-2019	All	All	AU_FM500001	AU_KM524555

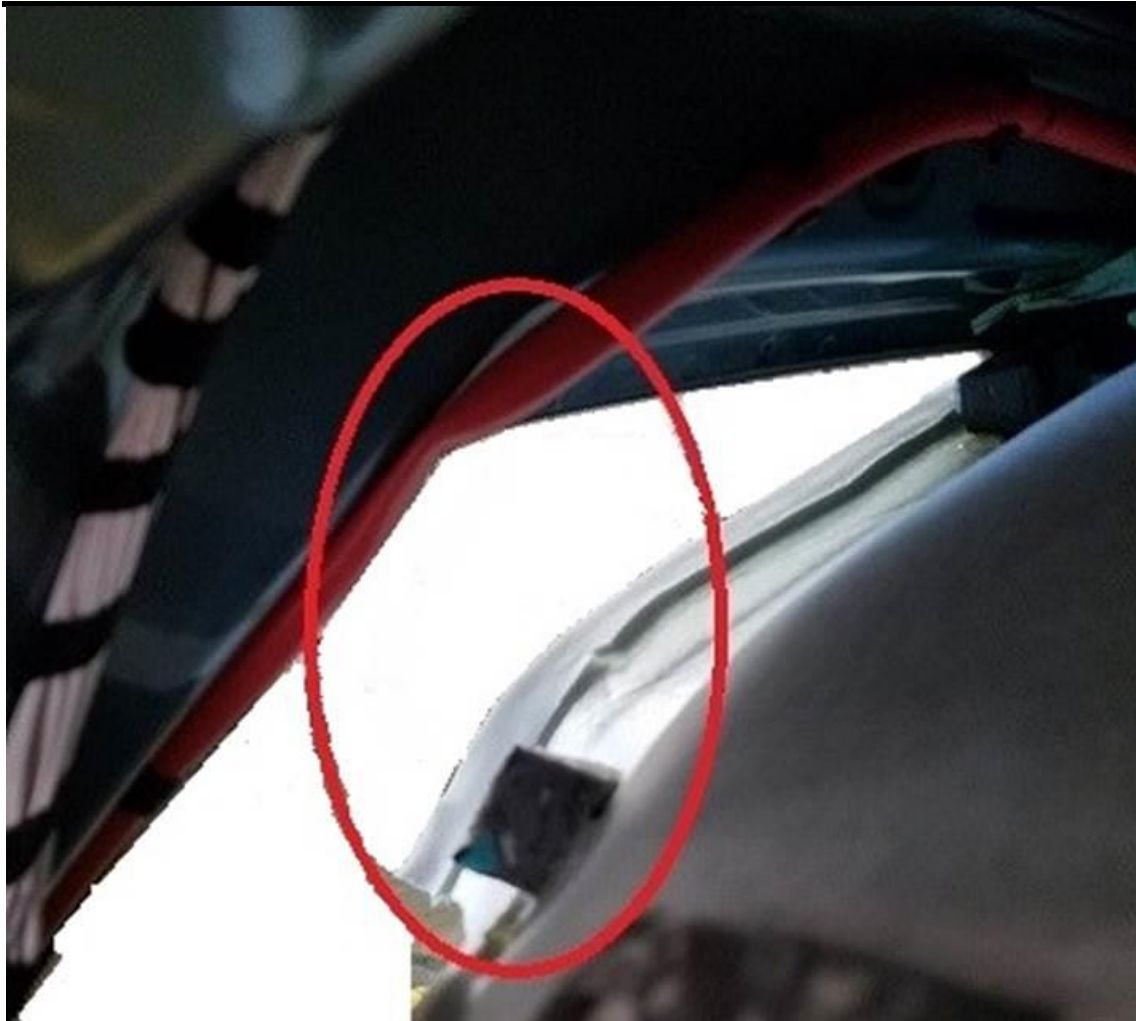
The rear sunroof drains may be pinched shut by foam blocks on the headliner, not allowing the sunroof frame to drain properly (See Figure 1).

Figure 1: Sunroof drain pinched by foam block on headliner

Incorrect assembly in production allows too much length in the sunroof drain between the second and third securing clips. This causes excess slack in the drain hose allowing the foam block to contact the hose.

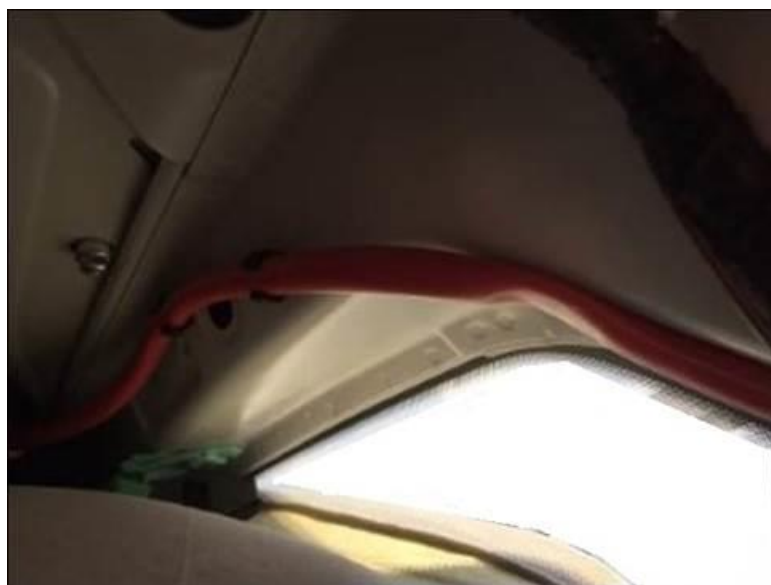
9. Carefully lower the rear of the headliner and inspect the rear sunroof drain hoses. The drain hoses should be replaced if they show signs of being pinched by the foam blocks on the headliner (Figure 3).

Figure 3: Impression on rear sunroof drain from contact with headliner foam block.

1. Finish removing the headliner. See repair manual group 70 in ELSA.
2. Remove and replace the rear sunroof drain hoses. See repair manual group 60 in ELSA.

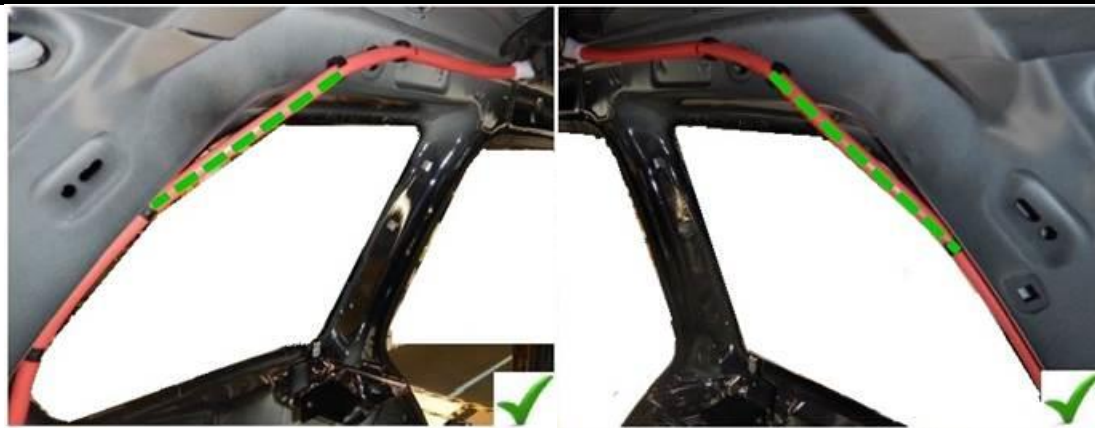
Figures 4 and 5: Correct routing of left and right rear drain hoses with no slack between the 2nd and 3rd mounting clips.

The new hoses (longer than original) should be cut to match the length of the original hoses prior to the installation. During installation of the new drain hoses, ensure the hoses are pulled taught between the 2nd and 3rd mounting clips with no excess slack in the hoses (See Figures 4 and 5).

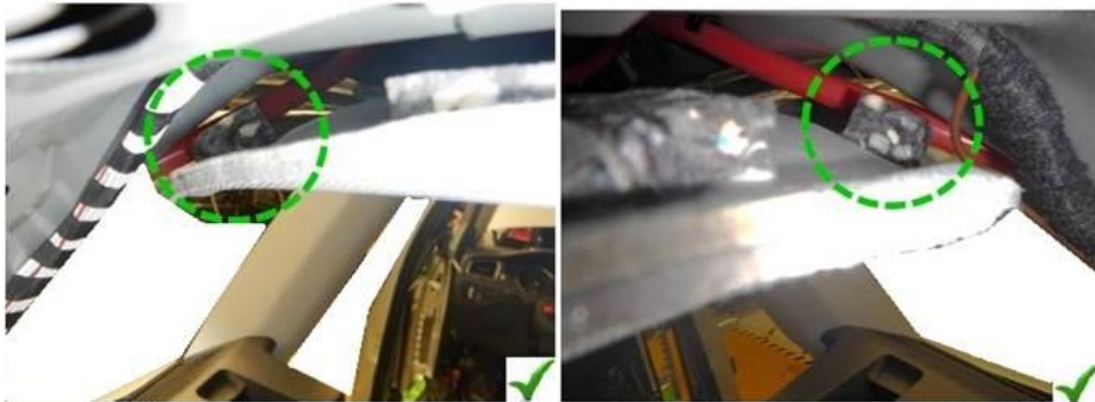
Figures 6 and 7, Rear drain hoses routed behind foam blocks on headliner.

3. Reinstall the headliner ensuring the foam blocks do not contact either of the sunroof drain hoses (See Figures 6 and 7).
