Service Action

Code: 57H3

Subject e-tron Service Package

Release Date February 25, 2020

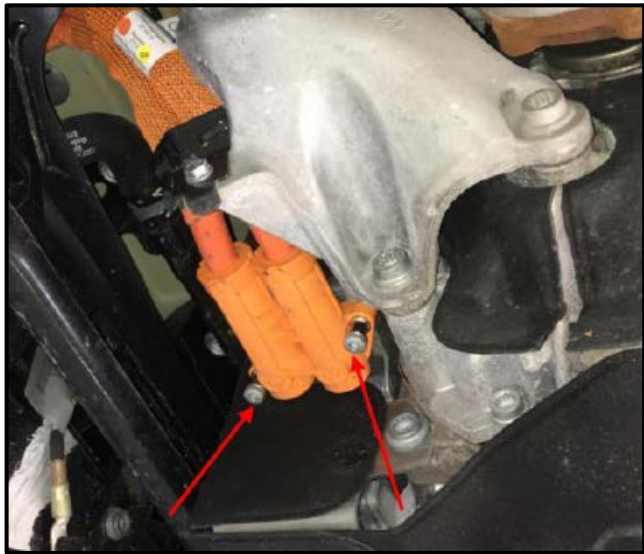
- If the high-voltage cable is still making contact:
- De-energize the high-voltage system.

- See ELSA Repair Manual: *Repair manual > Motor > Electric Drive Motor 0EF > 93 Electric drive > High-Voltage System, De-Energizing*
- Remove bolts <arrows>.
- Unplug connector.
