Noise Symptom - Whining and Clicking Noises from A-Pillar Area at Low Engine Load/During Overrun: Reworking Torque Support (SY 29/19)

Vehicle type: **Cayenne Turbo (9YA)**

Model Year: **As of 2018 up to 2019**

Subject: **Torque support**

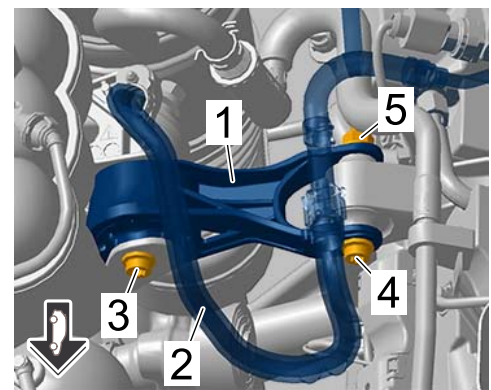
*Torque support***Concluding work**

Cause: Noise from the engine's valve drive can be transferred to the body via the torque support.

- Work Procedure: 1 Unscrew bolt ⇒ *Torque support -3-* and remove together with washer.
- 2 Install **new** bolt with **new** washer and tighten to **Tightening torque 55 Nm (41 ftlb.)** .
