**Noise Symptom - Squeaking While Steering: Checking Installation Position of Dust Boot on Steering System (SY 103/19)**

Vehicle Types: **911 Carrera S (992)/911 Carrera 4S (992)/911 Carrera S Cabriolet (992)/911 Carrera 4S Cabriolet (992)**

Model Year: **2020**

Concern: **Power-steering gear**

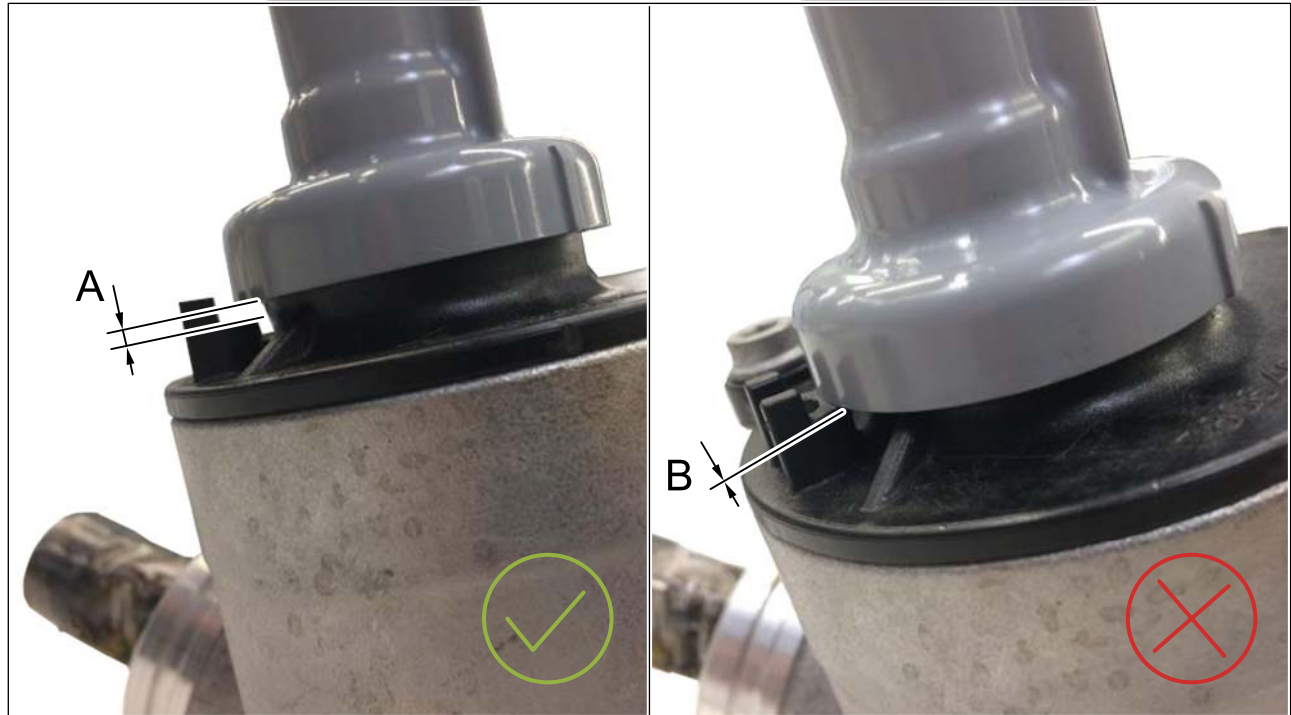
*Checking dust boot*

Cause: The dust boot on the power-steering gear may have been pressed in too far during production and as a result, it may rub against the power-steering gear housing while steering.

- 1.1 **If the gap is OK (⇒ *Checking dust boot -dimension A-*):**  
The dust boot is not the cause of the squeaking noise — Install front-axle support, see ⇒ *Workshop Manual '400819 Removing and installing front-axle support'*.
- 1.2 **If the gap is not OK (⇒ *Checking dust boot -dimension B-*):**  
The dust boot is causing the squeaking noise. Continue with Step 2.

**Dimension A** – ~ 2 mm

**Dimension B** – ~ 0 mm

Remedial Action: In the event of a customer complaint, check the installation position of the dust boot and replace it if necessary.
