Technical Information Bulletin

E261

PACCAR MX-13 EPA2017 Oil Thermostat and Filter Cap Replacement with Oil Survey

2/14/2020

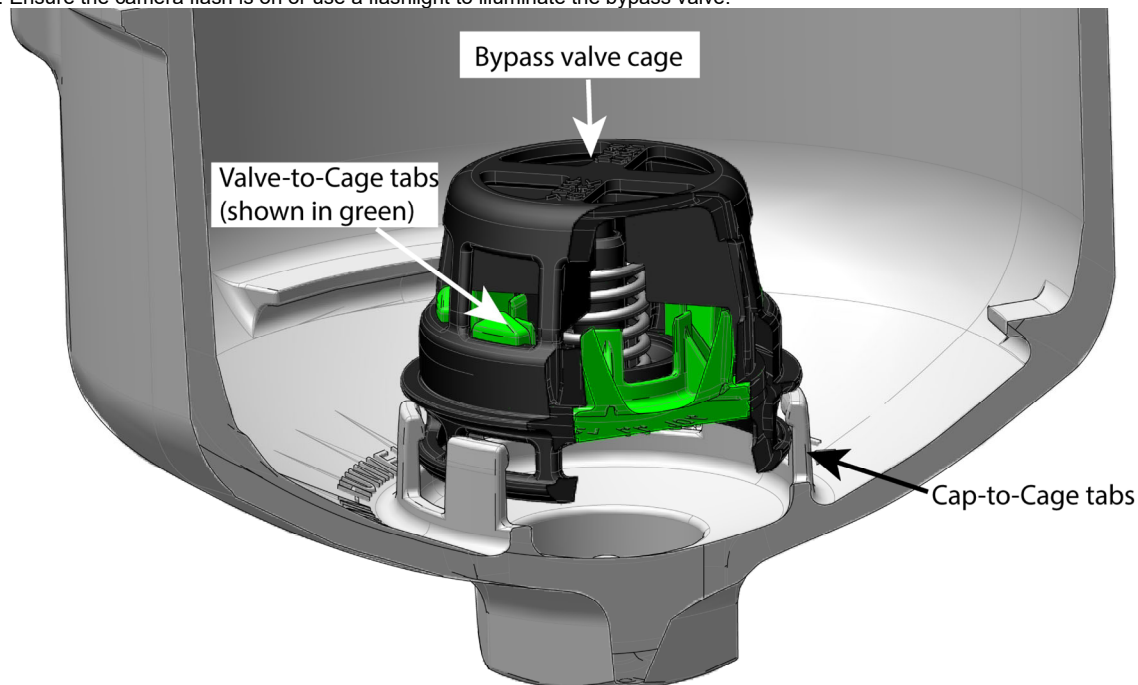
- On the Engine Oil Module, remove the filter cap.
- Remove the oil filter cartridge.
- Carefully, without damaging the filter, inspect the oil filter cartridge pleats for debris. If significant debris is found, take photos. The oil filter will have small amounts of debris as by design function of the oil filtration system.
 - A replacement oil filter is not included with this repair.
- Inspect the retaining tabs that hold the bypass valve cage to the filter cap and the tabs that hold the bypass valve to the cage. If any of them are broken, take clear photos.

TIP: Ensure the camera flash is on or use a flashlight to illuminate the bypass valve.

- If broken bypass valve tabs are found or debris is found in the filter pleats, start a TCS365 case and await instructions from the VSC. Provide the following information in the case:
 - If tabs are broken
 - if significant debris was found in the filter pleats
 - attach photos
- Refer to the following procedure for the Lubricating Oil Thermostat replacement procedure. When the procedure is published in RMI, this bulletin will be updated to reference the procedure in RMI.

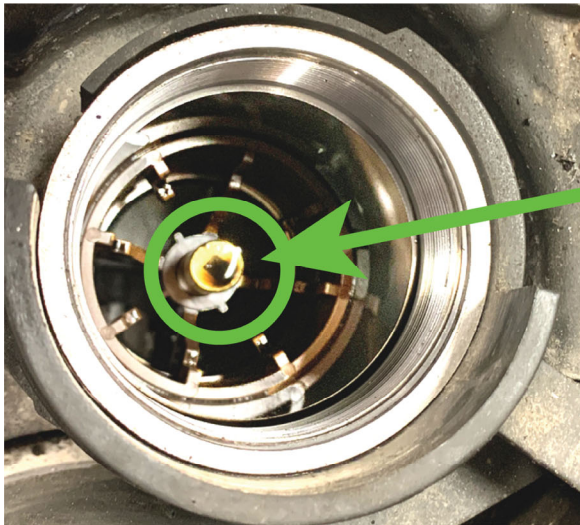
Removing the sleeve valve (3) without holding the thermostat may cause the thermostat to separate from the valve and drop into the oil cooler.

Grasp here with pliers

- Remove the spring from the oil module.
- Use pliers to grasp the thermostat, then remove the thermostat (2) and sleeve valve (3) together.

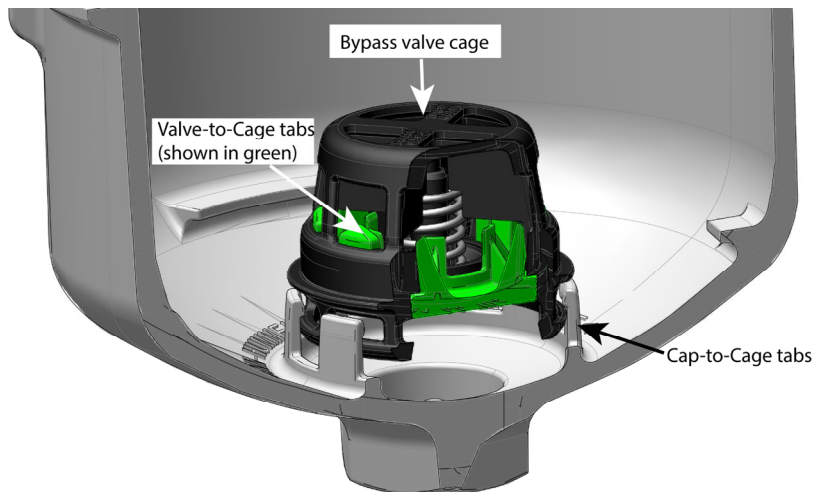
2. On the Engine Oil Module, remove the filter cap and replace with a new one.
3. Remove the oil filter cartridge.
4. Carefully, without damaging the filter, inspect the oil filter cartridge pleats for debris. If debris is found, take clear photos.
 - A replacement oil filter is not included for this repair.
5. Inspect the retaining tabs that hold the bypass valve cage to the filter cap and the tabs that hold the bypass valve to the cage. If any of them are broken take clear photos.
 - Tip: Ensure the camera flash is on or use a flashlight to illuminate the bypass valve.
6. If broken bypass valve tabs are found or debris is found in the filter pleats, start a TCS365 case and await instructions from the VSC. Provide the following information in the case:
 - If tabs are broken
 - If there is debris in the filter pleats
 - Attach photo

7. Refer to RMI for the Lubricating Oil Thermostat replacement procedure.
