## Technical Information Bulletin

**02-157**

Vehicle Model Year 2020-2021 T680, T880, W990 Windshield Seal Delamination

2/26/2020

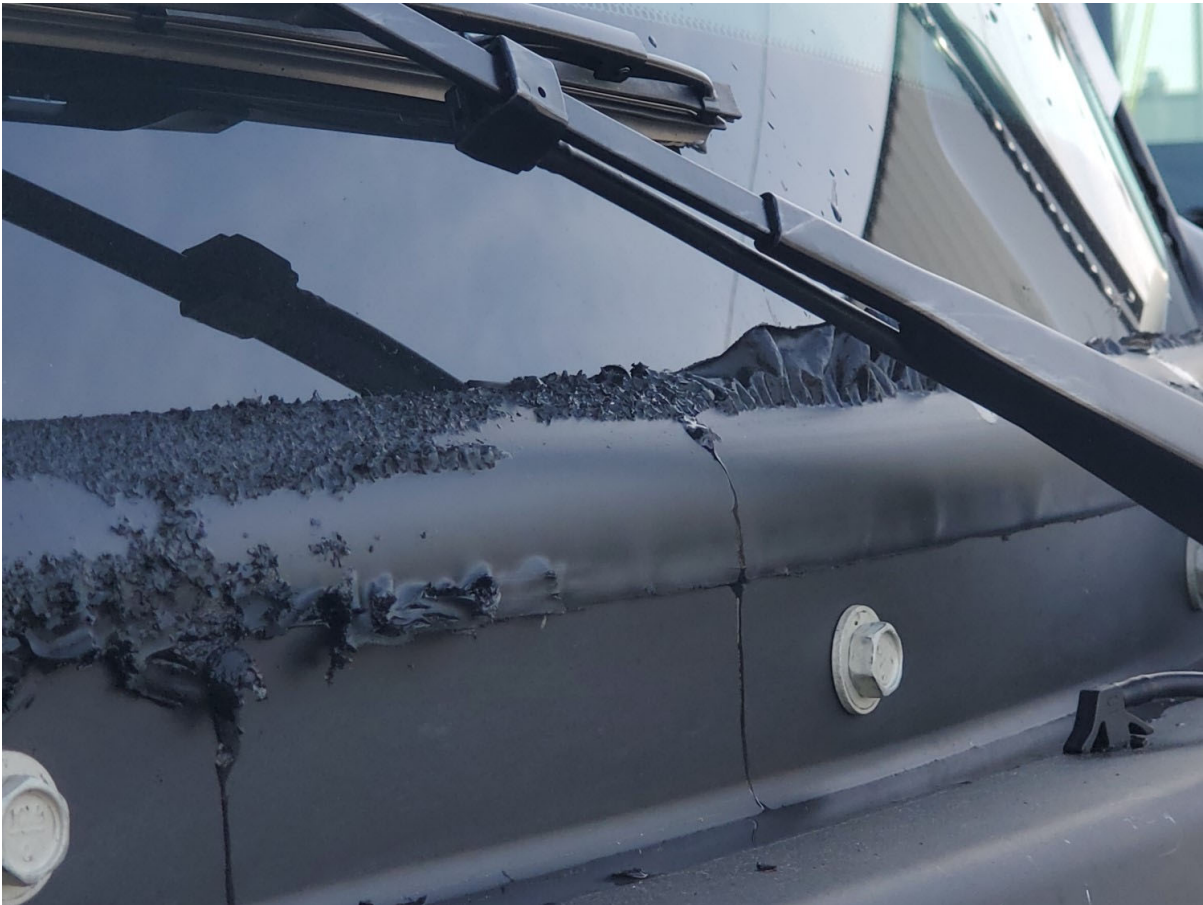
The windshield seal may be delaminated.

1. Inspect the windshield for signs of delamination as shown in the picture below. If delamination is observed, take a clear and focused picture of the delamination and submit the picture with the warranty claim.

2. Replace the windshield.
3. If the vehicle is equipped with a Bendix Fusion camera attached to the windshield (windshield p/n R44-6099), use the camera installation procedure found in [Bendix Service Manual SD-64-20124](#).
