Technical Information $\begin{array}{c} \text{Service} \\ \text{22/13} \text{ \tiny ENU} \end{array} \hspace{-0.2cm} 7413 \end{array} \hspace{-0.2cm} \boldsymbol{7}$

Complaint "Seat Cover Wrinkled" (22/13)

Model line: All model lines

Concerns: Look of the seat cover

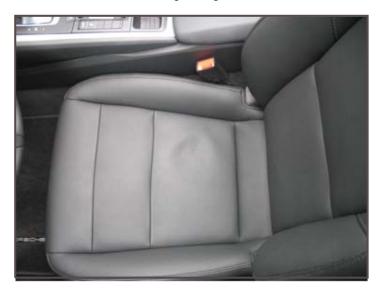
Figure 1

If wrinkles or bulges are visible on a seat cover (e.g. \Rightarrow *Figure 1*), these do not constitute a defect.

- This stretching is irreversible and is the kind of stretching that body weight, heat and perspiration normally cause. /⇒ Wrinkling, creasing and bulging are results of this kind of normal stretching (as shown in the above photo of the seat.
- The larger the upholstered surface, the greater the tendency to crease and bulge.

\Rightarrow If a visual flaw that is **clearly different** from the "natural characteristics" described here is found, the seat cover must be replaced:

• The seat cushion is not the cause of these wrinkles and must not therefore be replaced.
