AC Switch Panel Discolored at Edges

Models	Model Year	Model Type	VIN Range	Vehicle-Specific Equipment
Cayenne	2019-2020	E3	N/A	N/A

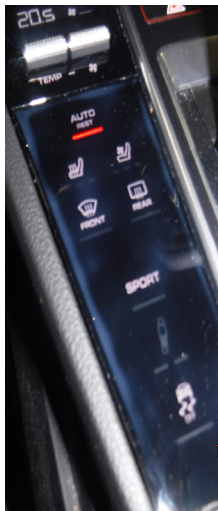
The AC Switch Panel can become discolored at the edges.

The discoloration is the result of too much solvent in the paint under the surface.

Replace the AC Control Panel
All old parts have been purged from stock.
