Key Programs More Readily When Placed Directly on Transmitter

Models	Model Year	Model Type	VIN Range	Vehicle-Specific Equipment
Taycan	2020	Y1A	N/A	N/A

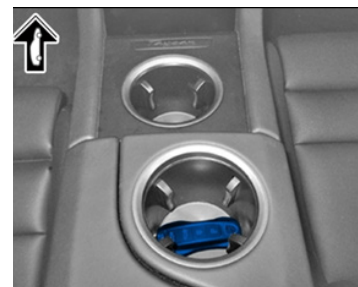
Figure 1

After many attempts, key programming is not successful for one or more keys. The workshop may observe this condition while performing WKK8.

In cases where the workshop experiences this condition, programming is often successful after placing the key in direct contact communication device (found under the cup holder) instead of in the emergency start tray. (the key reading location found in the cup holder – see figure 1).
