Pre-Delivery Inspection Test Drive for Drivetrain

Models	Model Year	Model Type	VIN Range	Vehicle-Specific Equipment
Taycan	2020	Y1ADB1, Y1AFC1, Y1AFH1	N/A	N/A

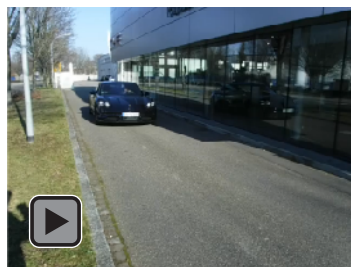
Video 1

A loud knocking noise can result from the rear drive module (transmission and electric motor) that is particularly audible when accelerating to approximately 38 mph (60 km/h). Additionally, a warning message(s) can result simultaneously in the cluster with the text, "reverse not available," and or "parking lock not available."

The damage associated with the noise described herein occurs in the transmission. This damage can already occur during low vehicle mileage.

- Listen to and watch the attached film to be able to recognize the damage discussed in this ATI
- Activate the "Sport" driving profile
- Perform a full load acceleration from a standstill (0 mph) to a maximum speed of 38 – 50 mph (60–80 km/h), conduct this acceleration three times
- Bring the vehicle to a complete stop before accelerating again, after every single acceleration
- If this noise does not occur during the test drive, then the vehicle may be delivered to the customer
- If this noise does occur, please open a PQIS entry immediately, and proceed to replace the rear drive module
