2017-2020MY
Niro (P/HEV)

PS647

ENGINE ELECTRIC WATER PUMP (EWP) CONNECTOR AND PIGTAIL ISSUES FOR DTC U045600

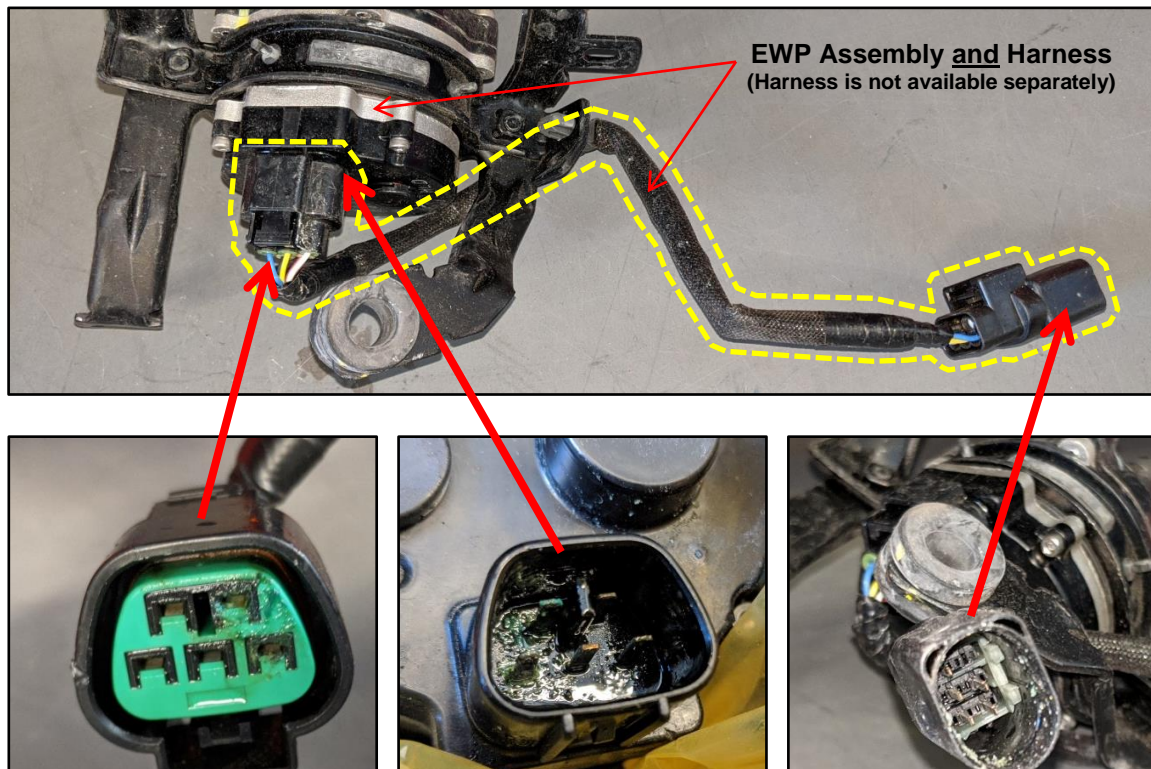
This Pitstop provides information regarding DTC U045600 on some 2017-2020 Niro (P/HEV) vehicles, which may set due to the EWP and/or harness connectors (C102) being contaminated with coolant. In the event that this DTC is set, thoroughly inspect the EWP and harness connectors which are located behind the Engine Coolant Temperature Sensor (ECTS) and are sometimes difficult to see.

Note: In some instances the Module 8 fuse and the EWP fuses will be blown as a result of the coolant contamination. Be sure that both fuses are checked for continuity after replacing the EWP and short harness. Note: Harness is not sold separately, however it is included with a new EWP assy.
