MODEL
2020MY
Telluride (ON)

NUMBER
047

TECHNICAL SERVICE BULLETIN

SUBJECT: REAR HVAC CONTROL HEAD MEMORY UPGRADE

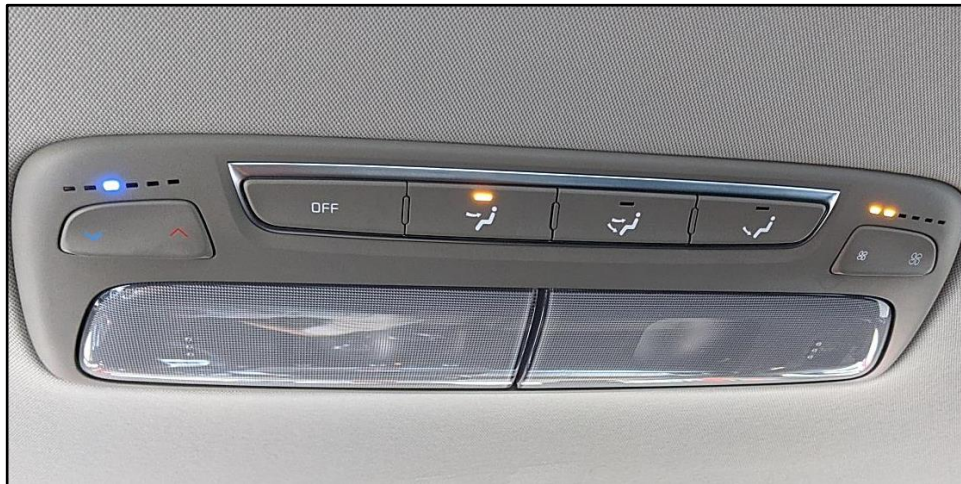
This bulletin provides the procedure to perform a wire harness upgrade on some 2020MY Telluride (ON) vehicles, produced from January 8, 2019 through June 4, 2019, which may experience a condition where the rear HVAC control head does not retain its previous settings and/or may reset to A/C on after the vehicle is turned off for a prolonged period of time. Follow the procedure outlined in this bulletin to perform the wire harness upgrade to retain the previous rear HVAC control head setting.
