GROUP <b>ENG</b>	MODEL <b>2017-2018MY Forte (YDm)</b>
	NUMBER <b>208 (Rev 2, 02/28/2020)</b>	DATE <b>June 2019</b>

## TECHNICAL SERVICE BULLETIN

**SUBJECT: ECU LOGIC IMPROVEMENT FOR P0300, P0301, P0302, P0303, P0304 AND/OR P219C00, P219D00, P219E00, P219F00**

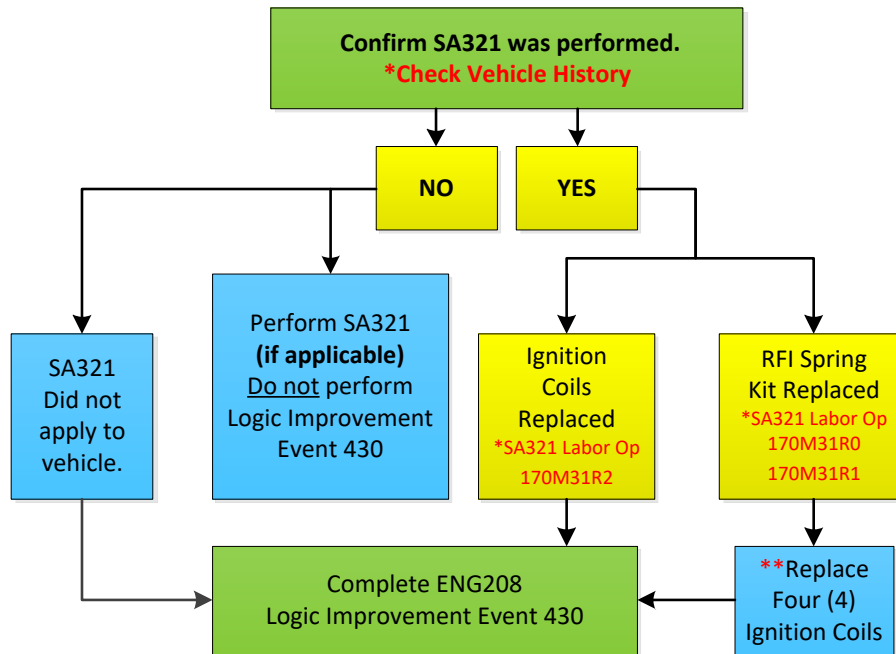
## Flowchart:

**Refer to Flowchart on page 2: Prior to upgrading the ECU Logic confirm SA321 has been completed.**

**\*Check Vehicle History \*\*Refer to LTS for Labor Op and Time to replace the ignition coils.**
