## Thor Motor Coach Technical Service Bulletin

| TSB # | <b>TSB 20-02</b> | | |
| Description/Title: | Super C Cabover Window | | |
| Affected Product Line(s): | All Model Year 2019 & 2020 Magnitude & Omni motorhomes | | |

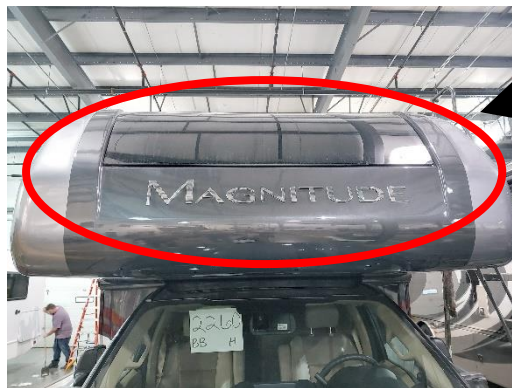
A topcoat sealant was provided by our vendor that did not meet Thor Motor Coach's standard for performance. This was used on 2019 & 2020 Magnitude and Omni Motorhomes. If the primary sealant does not provide sufficient coverage, the cabover window may experience water intrusion.

The repair will be to remove the existing topcoat sealant and apply the proper urethane sealant.
