Technical Service Bulletin

20-01-005H

SONATA (DN8)

ECM SOFTWARE UPDATE – GDI P0456 (SERVICE CAMPAIGN T4N)

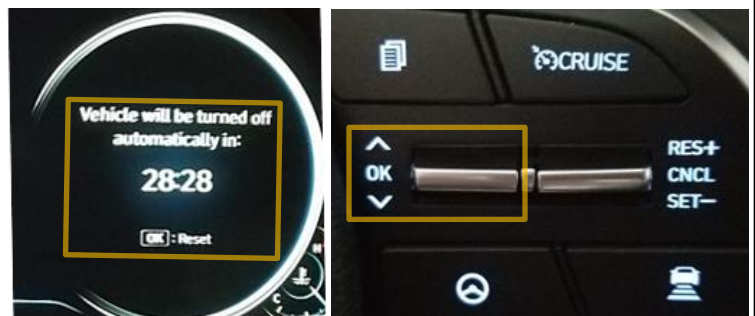
The ECM Software Update takes approximately 15 minutes to perform. However, the vehicle is equipped with a 30 minute factory default Vehicle Auto-Shut Off feature.

If the **Vehicle Shut-Off Timer: XX:XX** appears on the cluster, press **OK** on the steering wheel to reset the timer before starting the ECM update.

In the event of ECM update failure due to Vehicle Auto-Shut Off activation, perform the ECM update again in the **Manual** mode.
