# Latest Vehicle Concern Fixes

| BECM Setting P0C48 and/or P0E3B for HV Battery Coolant Pump | 20MY Range Rover & RR Sport PHEV |

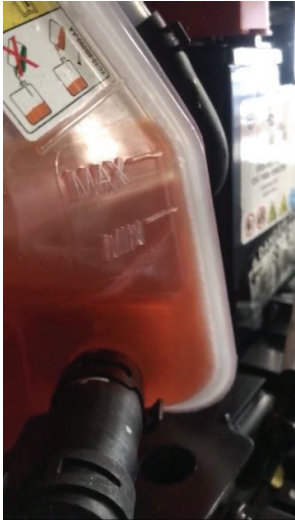
| BECM Setting P0C48 and/or P0E3B for HV Battery Coolant Pump | 20MY Range Rover & RR Sport PHEV |
|---|---|
| <p><b>Customer Voice:</b></p> <ul style="list-style-type: none"><li>• Check Engine MIL is on</li></ul> <p><b>Technical Description:</b></p> <ul style="list-style-type: none"><li>• P0C48-39 may be stored in the BECM for Hybrid Battery Pack Coolant Pump A Circuit Low- Signal has too few pulses.</li><li>• P0E3B may be stored in conjunction with the above code for EV Battery Coolant Pump Overspeed – Low Fluid Level</li></ul> <p><b>Status:</b></p> <ul style="list-style-type: none"><li>• Follow TOPIx steps for diagnosis for P0C48.</li><li>• Check Coolant level &amp; perform all appropriate electrical checks</li><li>• If no other root cause is found, bleed the system at least 5 times. Watch for air in the system during each bleed, if by the 5time, air is still found, bleed again until no air is found.</li><li>• Clear the DTC and test drive to verify CEL does not return.</li></ul> | |
