ITB19-041a

February 10, 2020

## 2020 Q50; BOTH CENTER DISPLAY SCREENS ARE BLANK

**APPLIED VEHICLE:** 2020 Q50 (V37)

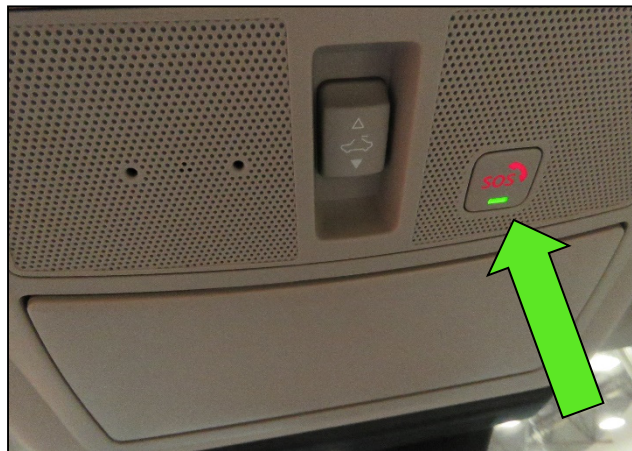
Figure 1

**APPLIED SYSTEM:** Vehicles equipped with factory navigation system (Vehicles equipped with navigation will have an SOS button in the overhead console assembly).
