HYUNDAI Technical Service Bulletin	GROUP FUEL SYSTEM	NUMBER 20-FL-001H
	DATE February, 2020	MODEL(S) ELANTRA (AD/ADA)
SUBJECT:	DTC P0300/P0301/P0302/P0303/P0304 ECM SOFTWARE UPDATE AND IGNITION COIL INSPECTION/REPLACEMENT

This TSB supersedes TSB 19-FL-006H-1 with revised ECM software update and ignition coil external body appearance information.

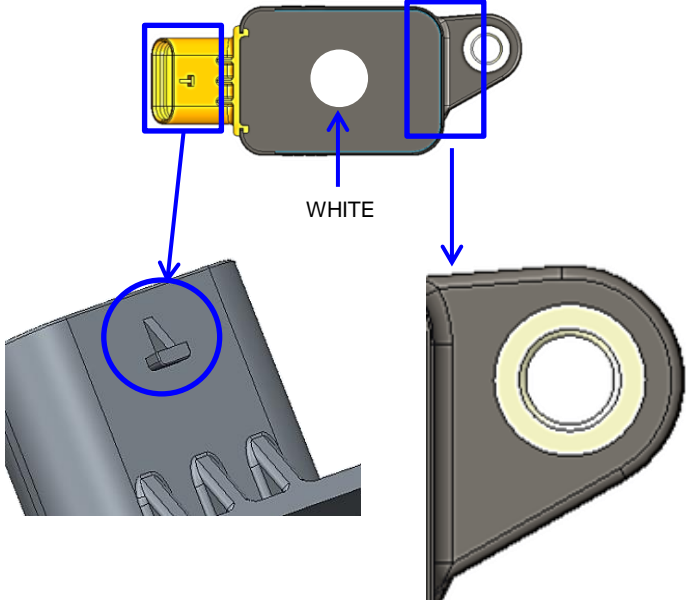
<p style="text-align: center;">WHITE</p>

PART NAME	PART NUMBER	REMARKS
IGNITION COIL	<p style="text-align: center;">27300-2E601</p> <div style="display: flex; justify-content: space-around;"> <div style="text-align: center;"> <p>Older Style</p>   <p>Replacement ignition coil with previous shaft design</p> </div> <div style="text-align: center;"> <p>Newer Style</p>   <p>Replacement ignition coil with updated shaft design</p> </div> </div>	<ul style="list-style-type: none"> Both the older and newer ignition coil shaft styles are interchangeable. Color marking inspection does not apply to the newer style ignition coil with updated shaft design. Replace if the vehicle ignition coil is the older style and has a WHITE or BLUE mark on top. Do not replace if the vehicle ignition coil is the older style and has a GREEN or GREY mark on top.

Older Style Ignition coil with WHITE Mark	Older Style Ignition coil with BLUE/GREEN/GREY Mark

1. Replace ignition coil(s) according to the shop manual.
 - Engine Electrical System > Ignition System > Ignition Coil
2. Perform GDS Mobile software update per TSB **15-GI-001**.
3. After successful completion of **ECM software update**, check for Diagnostic Trouble Codes in **ALL** menus and erase any DTC.
4. Confirm normal vehicle operation.
