# SERVICE BULLETIN

Classification: EL15-006t	Reference: NTB15-049t	Date: February 4, 2020
------------------------------	--------------------------	---------------------------

## TELEMATICS SERVICE INFORMATION

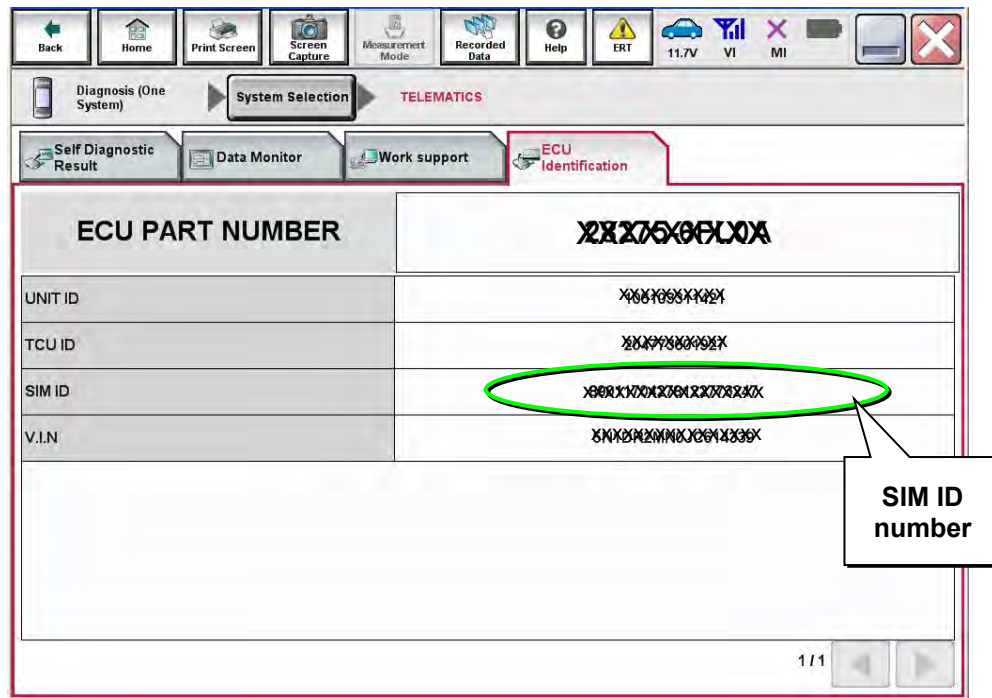
Figure 17

a. Navigate C-III plus to the screen shown in Figure 17.

**Diagnosis (One System) > TELEMATICS > ECU Identification**

b. Locate the SIM ID number and write it on the repair order as "New SIM ID".

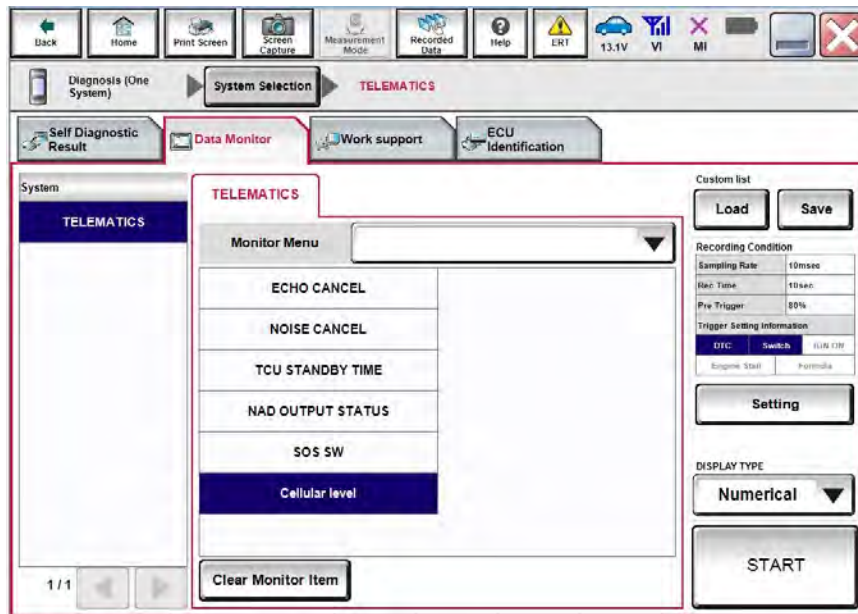
Figure 24

50. Check the **Cellular level** and confirm that it is “GOOD”.
51. If the **Cellular level** is MARGINAL or LOW, move the vehicle to an area with good signal.

**NOTE:** The **Cellular level** constantly updates. Safely relocate the vehicle until a “GOOD” **Cellular level** is received.

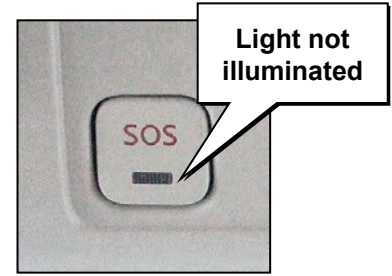
Figure 4a

**NOTE:** Dealer Demo mode will expire two months after the Vehicle Build Date. All services will be disabled including the SOS light. Do NOT replace the TCU.

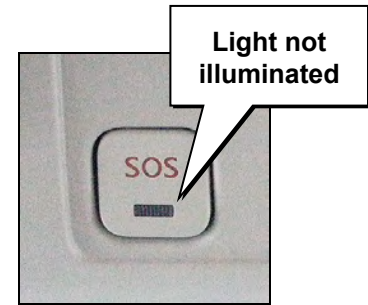
Figure 5a

1. With the vehicle in an area of known good reception, turn the ignition ON and check whether or not the green light on the SOS button is illuminated (see Figure 5a).

**NOTE:** It may be difficult to tell if the green light is illuminated if the vehicle is outside in bright sunlight.

- If the green light **is** illuminated, the process to turn ON the TCU is complete and no further action is needed.
- If the green light **is not illuminated**, go to **Turn ON TCU** on page 14.
