SERVICE BULLETIN

Classification: EL19-018a	Reference: NTB19-056a	Date: February 4, 2020
------------------------------	--------------------------	---------------------------

2018-2019 LEAF; LITHIUM-ION BATTERY WILL NOT QUICK CHARGE

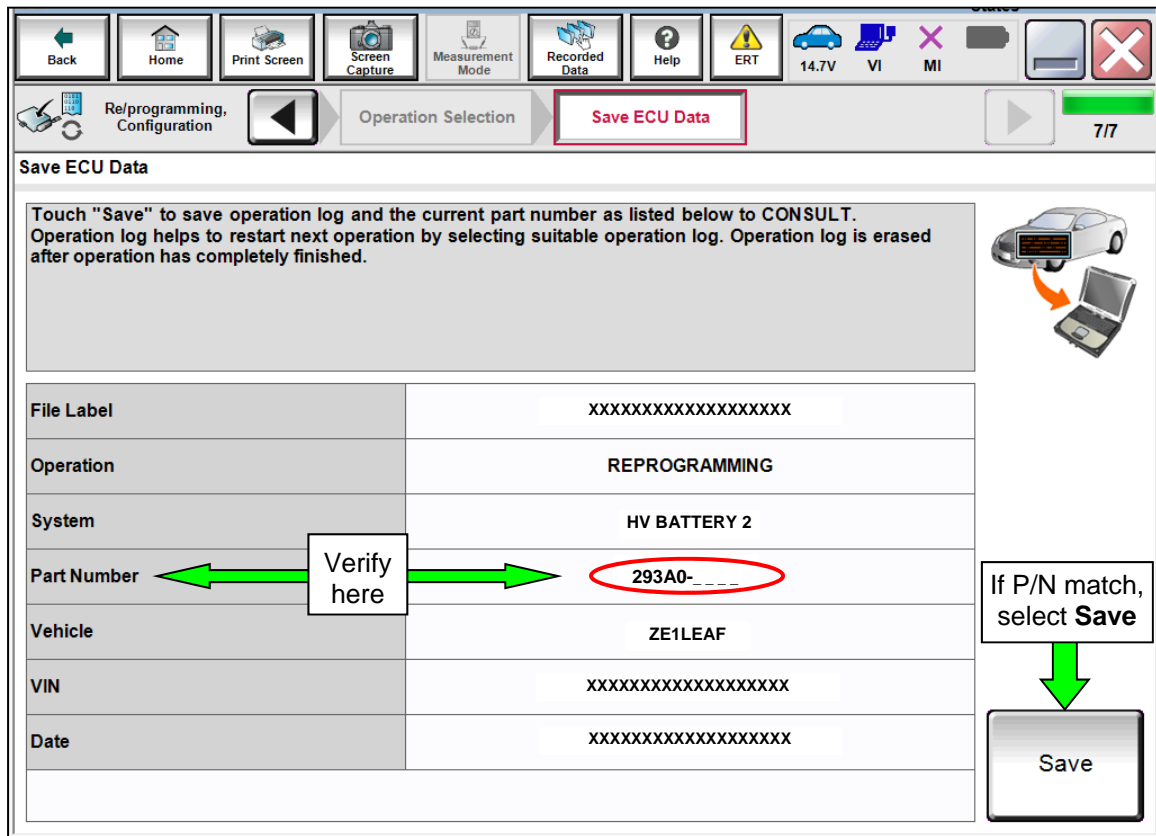
Figure 9

20. Find the **Part Number** (see Figure 9) and write it on the vehicle's repair order.
21. Compare the **Part Number** written down to those listed in **Table A** below.

- If there is a match, select **Save**, and then continue to Step 22.
- If there is not a match, this bulletin not apply. Go to ASIST and the Electronic Service Manual (ESM) for further diagnosis.

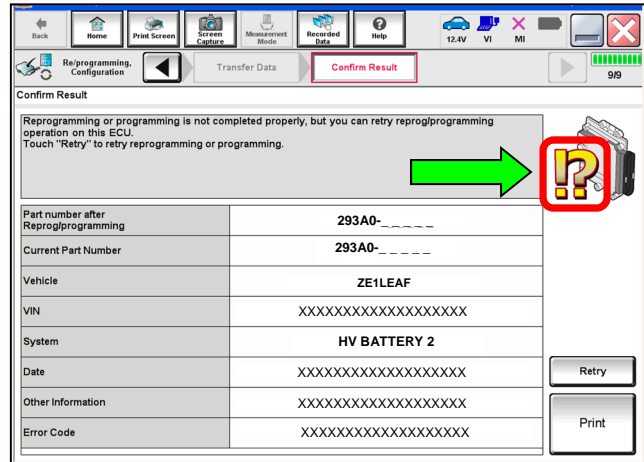
Figure 21

CAUTION: If reprogramming does not complete and the **!?** displays as shown in Figure 21:

- Check battery voltage (12.0-15.5V).
- Ignition is ON, Ready Mode is OFF.
- External Bluetooth® devices are OFF.
- All electrical loads are OFF.
- **Select Retry and follow the on screen instructions.**
- Retry may not go through on first attempt and can be selected more than once.

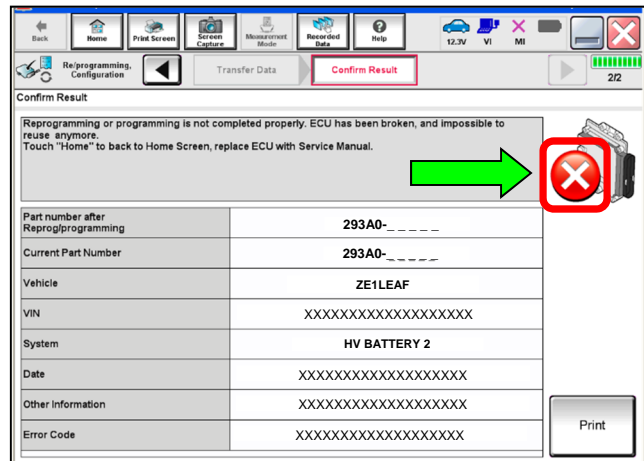
Figure 22

OR: If reprogramming does not complete and the **X** displays as shown in Figure 22:

- Check battery voltage (12.0-15.5V).
- Ignition is ON, Ready Mode is OFF.
- External Bluetooth® devices are OFF.
- All electrical loads are OFF.
- **Select Retry and follow the on screen instructions.**
- Retry may not go through on first attempt and can be selected more than once.
