SERVICE BULLETIN

Classification: EL20-001	Reference: NTB20-006	Date: February 10, 2020
-----------------------------	-------------------------	----------------------------

2018-2020 ARMADA; INFOTAINMENT ERROR MESSAGE "UNABLE TO CONNECT TO THE CENTER" DISPLAYED

APPLIED VEHICLES: 2018-2020 Armada (Y62)

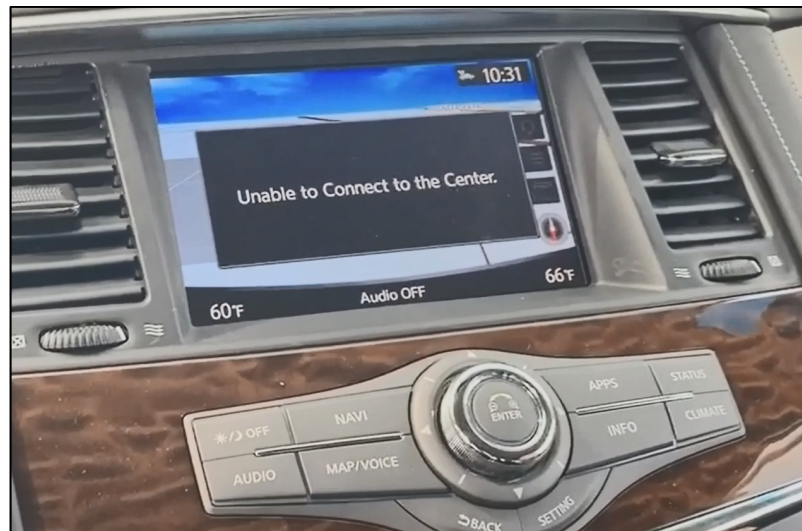
Figure 1

- The error message "Unable to Connect to the Center" is displayed on the infotainment screen (see Figure 1),

1. Identify the TCU ID.
2. Manually configure the display control unit.
