CAMPAIGN BULLETIN

Steering Gear Housing Inspection Dealer Inventory

Reference: PM936

Date: February 6, 2020

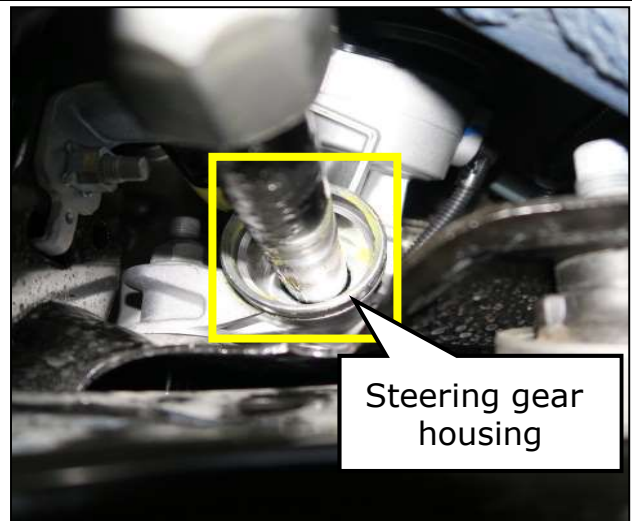
5. Inspect the steering gear housing in the area shown in Figure 5 for cracking.

- ▶ **NO**- Continue with **Step 7** for reassembly
- ▶ **YES**- Replace the steering gear and linkage assembly using the procedure outlined in the ESM. **STEERING - STEERING SYSTEM - UNIT REMOVAL AND INSTALLATION - STEERING GEAR AND LINKAGE**
 - Perform additional service after replacing EPS Control unit procedure outlined in the ESM **STEERING - STEERING CONTROL SYSTEM - BASIC INSPECTION - ADDITIONAL SERVICE WHEN REPLACING EPS CONTROL UNIT**
 - Perform front wheel alignment.

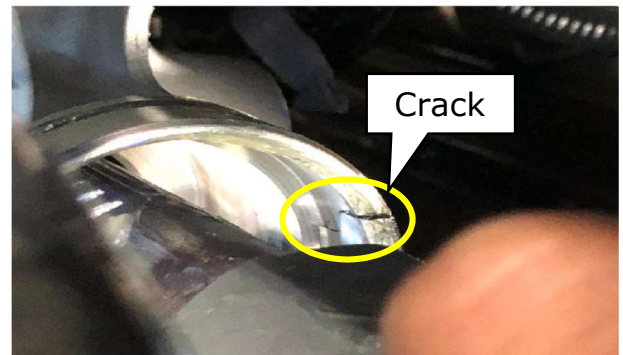
Figure 6

NOTE: Cracking may be similar to that shown in Figure 6.
